THROWN AWAY OR PUT AWAY? WINDOW GLASS FROM THE SECOND HALF OF THE 17TH CENTURY DEPOSITED IN TYKOCIN CASTLE, POLAND

Abstract: This study is dedicated to window glass discovered in Tykocin castle, deposited in the northern part of the complex, most probably dated to the 1660s. These are remains of windowpanes prepared for the glazing of windows during refurbishment and construction work in the castle building following its destruction in 1656. This paper contains descriptions of those finds including formal, metric and morphological features of the material, structure of the surface and evidence of technical procedures, the character of finds and the reason for the creation of the glass deposit. Finally, the paper discusses the time and circumstances in which the said glass was treated and processed.

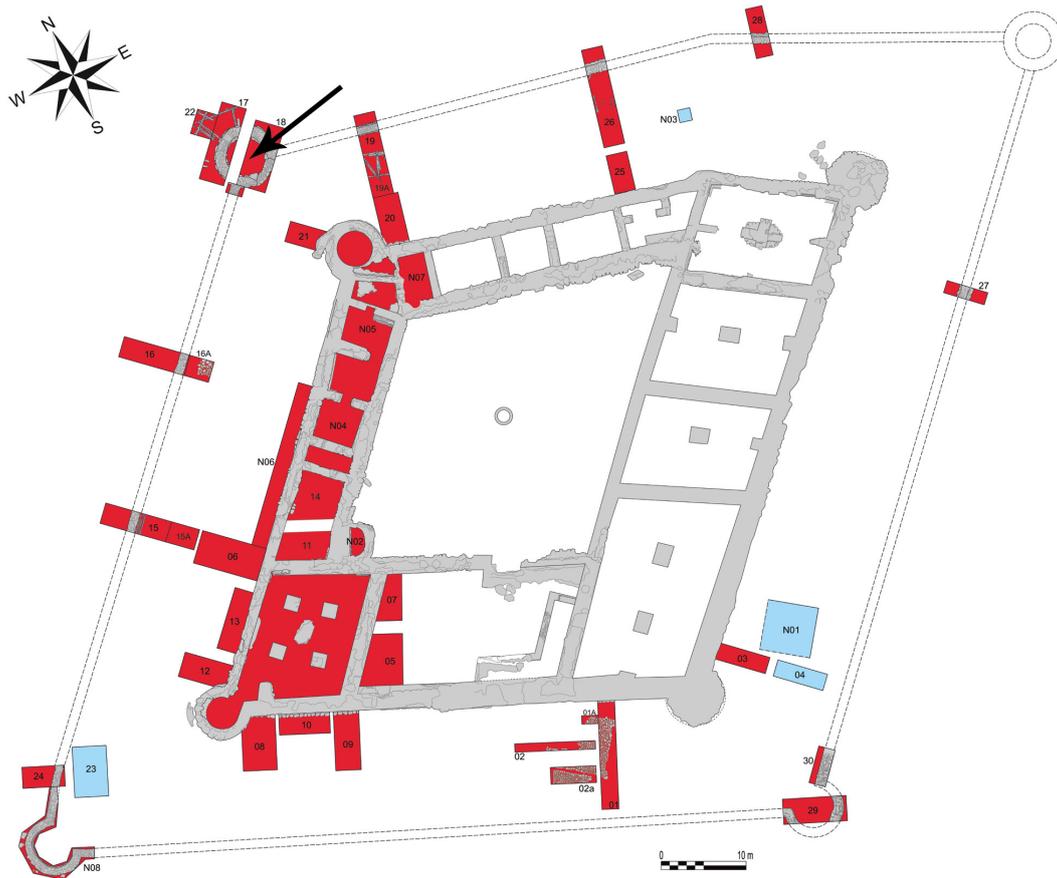
Fig. 1. Site plan showing relics of the castle and roundels in Tykocin unearthed during archaeological excavations in the years 2001-2007. The arrow points to the location of the deposited window panes from the second half of the 17th c. Key: 01-30 – excavation trenches; N01-N08 – watching briefs; dotted line – reconstructed outline of the roundels that functioned from the third quarter of the 16th c. to around second decade of the 17th c. Prepared by W. Bis.

The place of deposition of the analysed assemblage was located inside the north-western roundel (see Fig. 1). It is one of the elements that created a line of fortifications of the Renaissance castle built in the third quarter of the 16th century on the initiative and efforts of King Sigismund II Augustus. Roundels functioned for no more than half a century – from the third quarter of the 16th century to around the second decade of the 17th century. It is assumed that it was the time when older fortifications, including roundels, were demolished up to the level of their foundations, to make room for the construction of a more advanced bastion defence system (earth and timber structures further removed from castle walls). The demolition layer that is the evidence of those construction works and the remains of the pulled down buildings which remained below the ground level were covered with a layer of light-colour sand. Subsequently, next contexts accumulated over those two layers, including context number 04. Work associated with the demolition of old roundels and building new fortifications most probably took place between 1603 and 1613 during the reign of Sigismund III Vasa. Around that time, i.e. in the second or third decade of the 17th century, castle buildings themselves were also modernized,³⁴ and the castle remained in that form until the “Deluge” – the Swedish invasion. The siege in 1656 (27 January) resulted in the destruction of a part of the castle and the catastrophic consequence of those events were not remedied for the next hundred years, as two of four wings of the castle were destroyed.³⁵ Only the remaining two parts of the structure – probably the west and the south wing – continued to be used until the final decommissioning of the castle building in the end of the 1760s following the decision of Jan Klemens III Branicki, the owner of the castle at that time, who ordered to have them finally demolished.

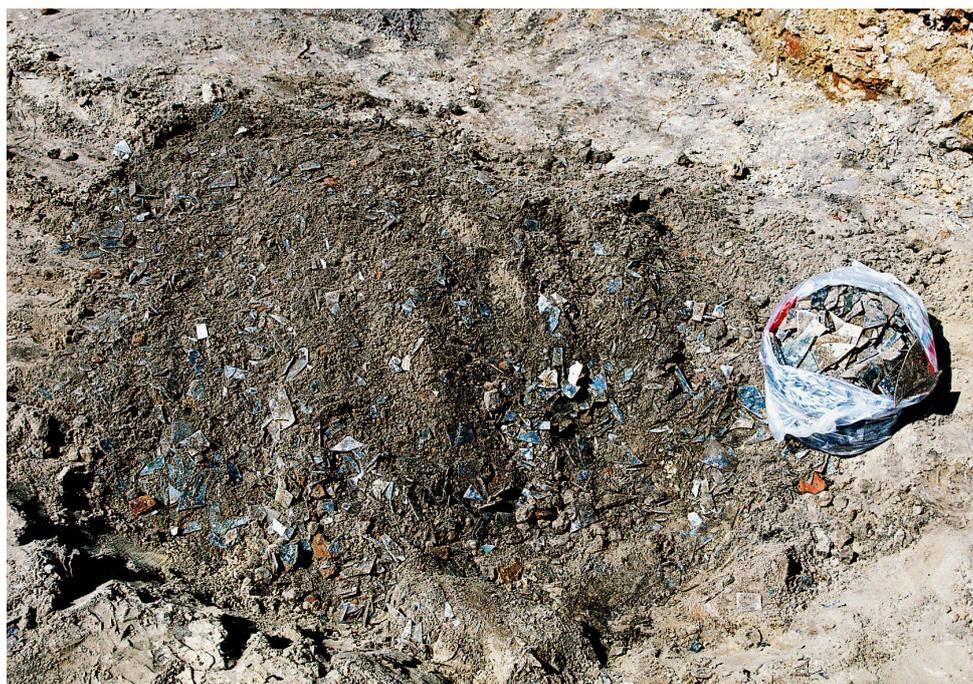
Fig. 2. Tykocin Castle. Context 04 in trench 18, in which window glass was deposited, during excavations in 2003. Photo W. Bis.

Glass finds that are the subject of this study were discovered during archaeological excavations carried out in the Tykocin Castle in 2003. They were recorded in a trench located in the northern part of the castle complex (trench number 18), outside the external line of castle buildings arranged in a quadrangle, planned diagonally to cardinal directions (Fig. 1). The assemblage was discovered in a sandy layer (number 04) that contained small fragments of lime mortar and brick rubble, on average 20 cm thick (Fig. 2). That context was dated generally to the period between the second half of the 17th century and the second half of the 18th century, and was counted among archaeological layers that constitute the sixth chronological level, i.e. the sixth of seven phases in the history of the Tykocin Castle complex.¹⁰

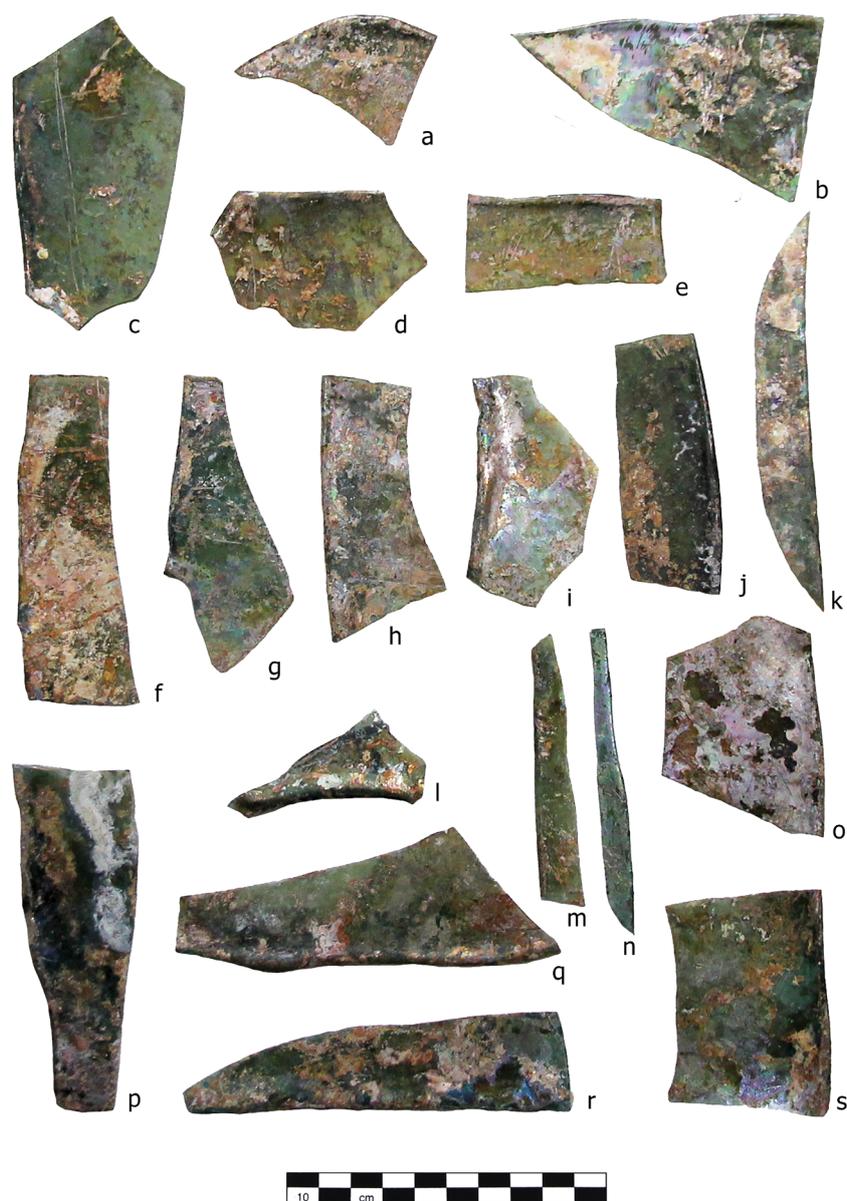
Fig. 3. Tykocin Castle. Windowpane glass and fragments thereof from the second half of the 17th century. Finds with preserved edges of sheets of glass. Photo and digital processing W. Bis.

The thickness of the glass ranged from 1 mm to 5.5 mm. Such large disproportions are the result of the greatest thickness being 3.5-5.5 mm, which were observed near the original edge of the glass sheet preserved in the case of a large number of finds (in total, 438 such glass fragments were recorded, which constitutes 1/3 of the entire assemblage) (Fig. 3:a-s). Edges of sheets of glass were rounded and thickened. Such edges survived on a number of finds from Tykocin, usually with the length of several centimetres, sometimes over 10 cm, but no more than 13.3 cm (Fig. 3:k). It was observed that the thickness of the glass gradually

Based on the analysed fragments, the thickness of the original edge of the sheet of glass determined its further use. If the thickness was equal and below 3 mm, it was cut and served as one of the edges of a new windowpane (Figs. 3:b-e; 4:a-b and 5:e, p-q). Where it

exceeded 3 mm, it was cut off and left in the form of trimmings of different width (Fig. 3:a, f-h, k-l). The former group of finds contained the greatest number of big glass fragments (having the largest surface in the entire assemblage), i.e. fragments with a surface of over 8 cm² (17 pieces). In one case the edge of the glass sheet was curled along a small section, and that part was cut off. Its thickness in this spot was as much as 7 mm; this value was created by a double sheet of glass: 3.5 mm thick each (Fig. 3:l). One piece of glass had a lentoid hole near the edge, with a diameter of 1 cm. That fragment was also cut off and became a useless scrap.

that the glazier using a sharp blade marked cut lines corresponding with future shapes of elements he was preparing (Fig. 3:c-g). Those scratch marks are at the same time the evidence of failures and errors made during the preparation of glass panes – of glass breaking off near the marked line and creating glass panes with asymmetrical edges. Breaking of the glass also not always went according to plan, which resulted in uneven edges.
