PAVEL DRNOVSKÝ*

HIGH MEDIEVAL FORTIFICATIONS IN VILLAGES NEAR HRADEC KRÁLOVÉ. MANORIAL RESIDENCES OF LOWER NOBILITY IN EAST BOHEMIA

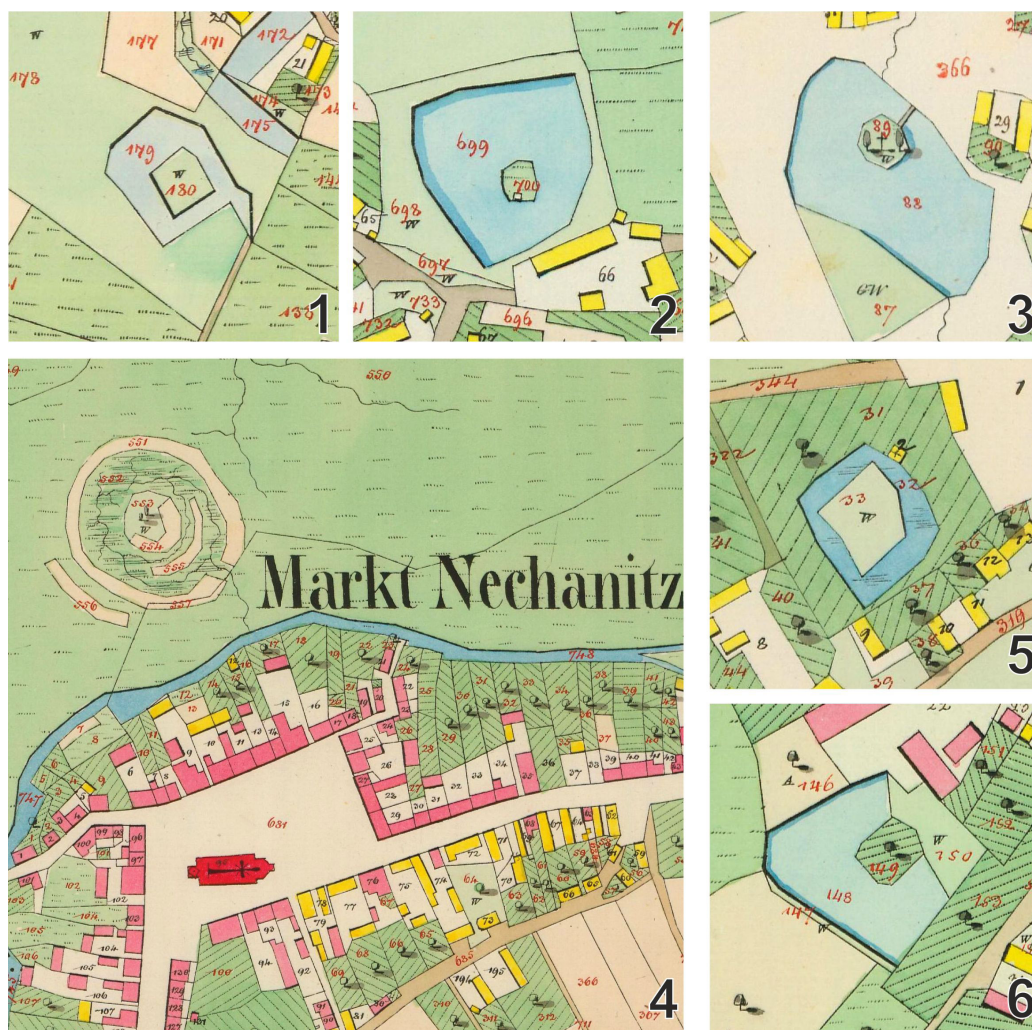
Fig. 2. Examples of 19th century cadastral maps depicting the extent of fortified manor houses: (1) Ohništany, (2) Libeň, (3) Obědovice, (4) Nechanice, (5) Radikovice, (6) Libčany. © Czech Office for Surveying, Mapping and Cadastre.

At the beginning of our research, we investigated the basic compendia of written sources related to the existence and localisation of manorial residences in the given region. Special attention was paid to the study of archival maps from the 18th and 19th centuries, with which we can follow the distribution of settlements in the past. Showing plot allotment in villages and in their fieldscapes, 19th century land register maps provided much valuable information. These maps often depict plots of land corresponding to the extent of original settlements, which were still visible in terrain at the time of mapping or their land allotment was at least partly detectable (Fig. 2).

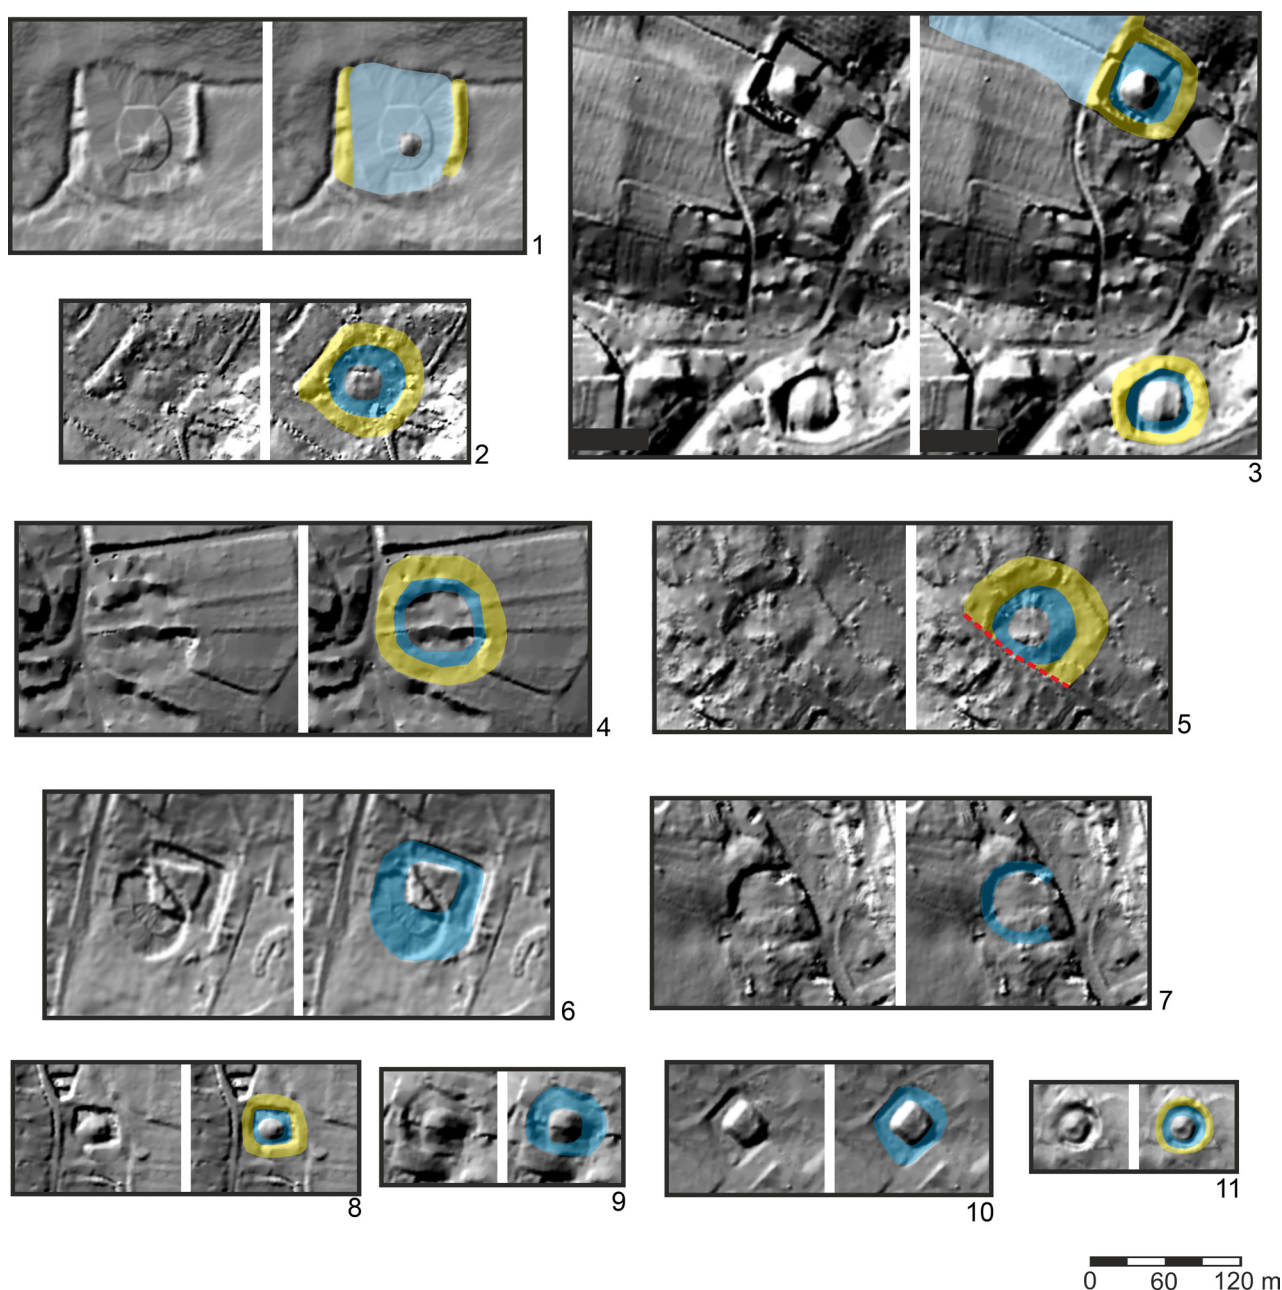
Fig. 5. Plans of fortified manor houses and their surroundings on a digital elevation model. On the left is a hillshade model, on the right is the interpretation of relics: dark blue – ditch, light blue – bodies of water (river, pond), yellow – rampart, central mounds without marking. (1) Libeň, (2) Ohnišťany, (3) Sekeřice 1 (northern fortified manor house) and 2 (southern fortified manor house), (4) Hustiřany, (5) Petrovičky, (6) Stračov, (7) Hrádek, (8) Chloumky, (9) Třebnouševs, (10) Habřina, (11) Dobeš. Graphic design: Pavel Drnovský.

rural development. The fortified manor house in the village of Dobeš is one of the better-preserved sites (Fig. 5:11). It is a residence of small dimensions with a preserved artificial mound, ditch, and rampart. The central mound is 22 metres in diameter, while the total diameter of the fortified area is 50 metres. Other fortified manor houses which were situated within the area of a village include those at Habřina (Fig. 5:10), Chloumky (Fig. 5:8), Hrádek (Fig. 5:7), Hustířany (Fig. 5:4), Ohništany (Fig. 5:2), Petrovičky (Fig. 5:5), Rakov, Sekeřice (southern fortified manor house) (Fig. 5:3), Stračov (Fig. 5:6), and Třebnouševy (Fig. 5:9).

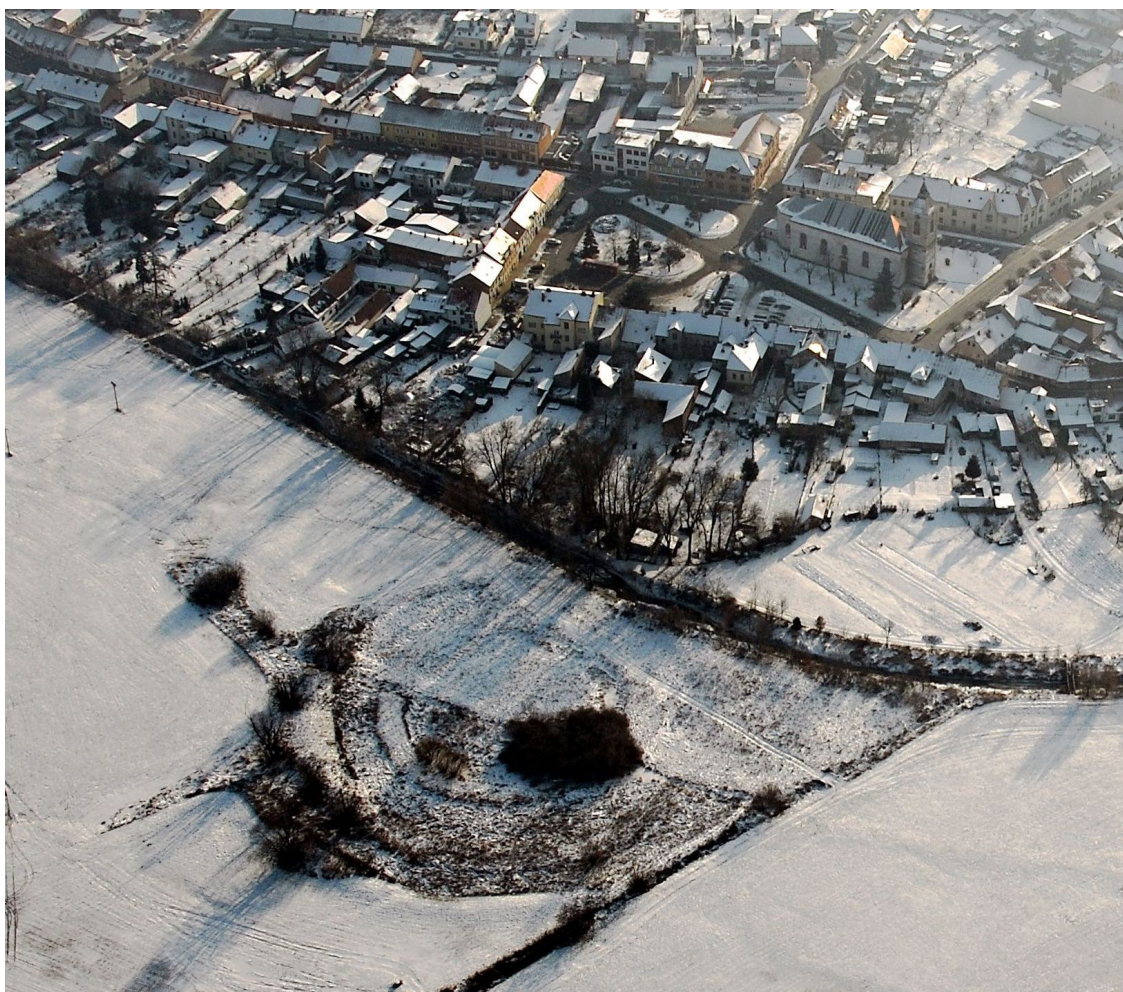
Fig. 6. Nechanice, example of relics of a fortified manor house by a river and town. Source: Gojda 2012.

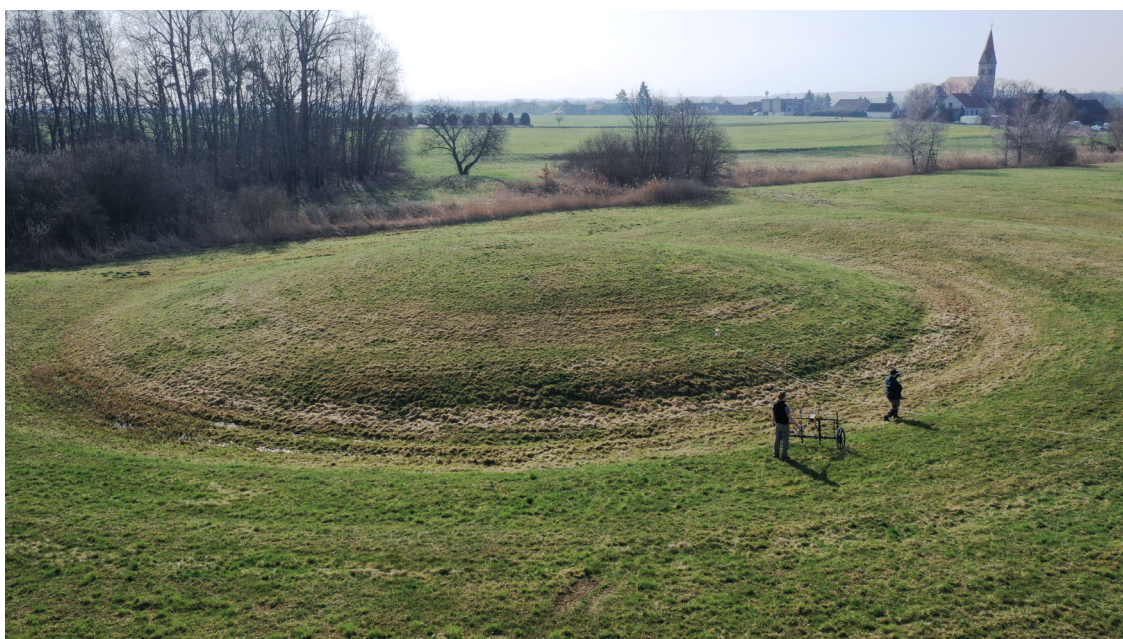
Fig. 7. Babice, example of relics of a fortified manor house by a pond and near a town. Photo: Š. Kravcic.
