MAGDALENA SUGALSKA*

HOW COOPERATION BETWEEN ARCHAEOLOGISTS AND ART CONSERVATORS HELPS US DISCOVER MORE INFORMATION: ARCHAEOLOGICAL INVESTIGATIONS AT THE JEWISH CEMETERY ON OKOPOWA STREET IN WARSAW

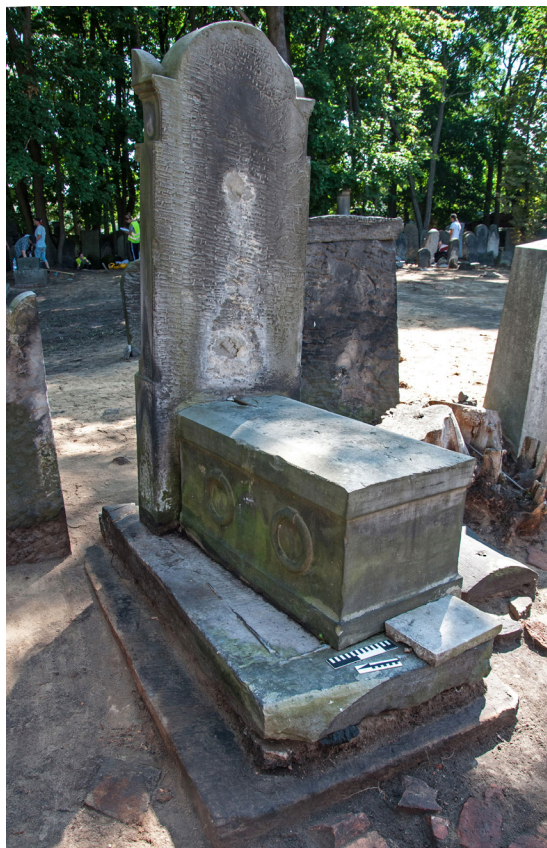
Fig. 1. Warsaw, Wola necropolis. Two types of gravestones: grave no. 429 – a stele with a type one monolithic block, grave no. 428 – an intermediate form between the monolithic type and stone box type. Grave no. 428 – state after conservation. Photo: M. Sugalska.

An ornamental stele with a monolithic block¹⁴ is a type of tombstone in which a stone or concrete elongated block is attached to the stele, with a semicircular or rectangular coping, placed over the entire burial chamber (Fig. 1). Its function was

Stone box graves in plot 1 usually consist of a stone foundation on which stands a high, oblong, rectangular stone box covered with a flat slab and a high stele with an inscription on the eastern side. The sides of the box are sometimes decorated with carved circular pseudo-handles. These monuments often have decorated iron fences (Fig. 1).

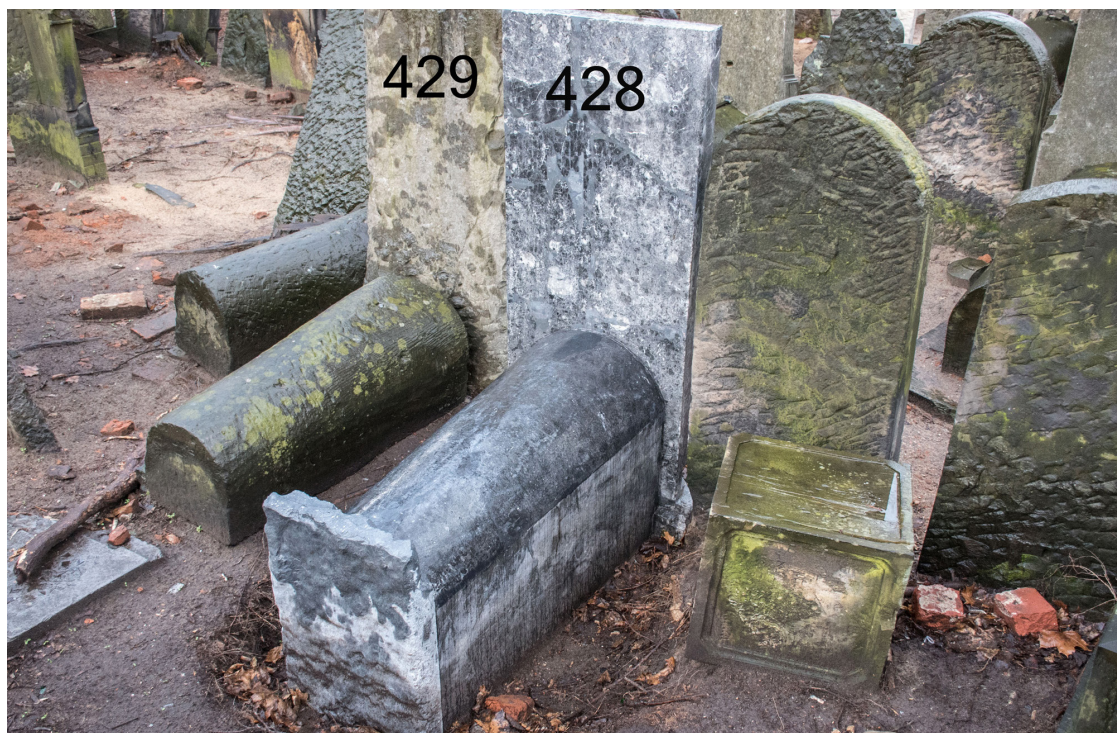
Fig. 2. Warsaw, Wola necropolis. A stone box type tombstone. Photo: M. Sugalska.

Monuments with the above-mentioned tombstone structure are an intermediate form between the stele-shaped tombstones with a monolithic block and the stone box type. The visual effect is similar to that of the monolithic block, but the monolithic block is replaced by two rectangular plates that form a support for the coping, usually in the form of a half-cylinder. The shorter end of the block is crowned with a lower stele, as in the stone box types,¹⁶ which was probably intended to protect the free space created by such a structure (in a few cases they have an inscription) (Fig. 2).

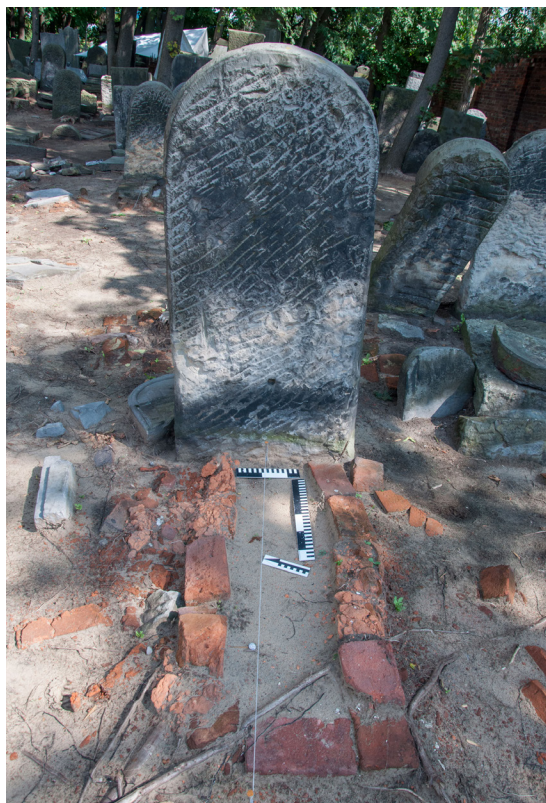
Fig. 3. Warsaw,
Wola necropolis.
Photo: M. Sugalska

In most cases, the outline of the burial chamber has been lined with the shorter sides of the bricks facing each other (the so-called header face) and the matzevah, while the end of the burial chamber is accentuated by the brick(s) laid perpendicularly to the longer sides (Fig. 3). Less frequently, bricks are laid facing each other with their longer sides (the so-called stretcher face) in relation to each other and to the matzevah. In a few cases, the centre of the resulting chamber is lined with bricks, presumably to reinforce the ceiling of the chamber, on which a rectangular stone slab was sometimes placed.

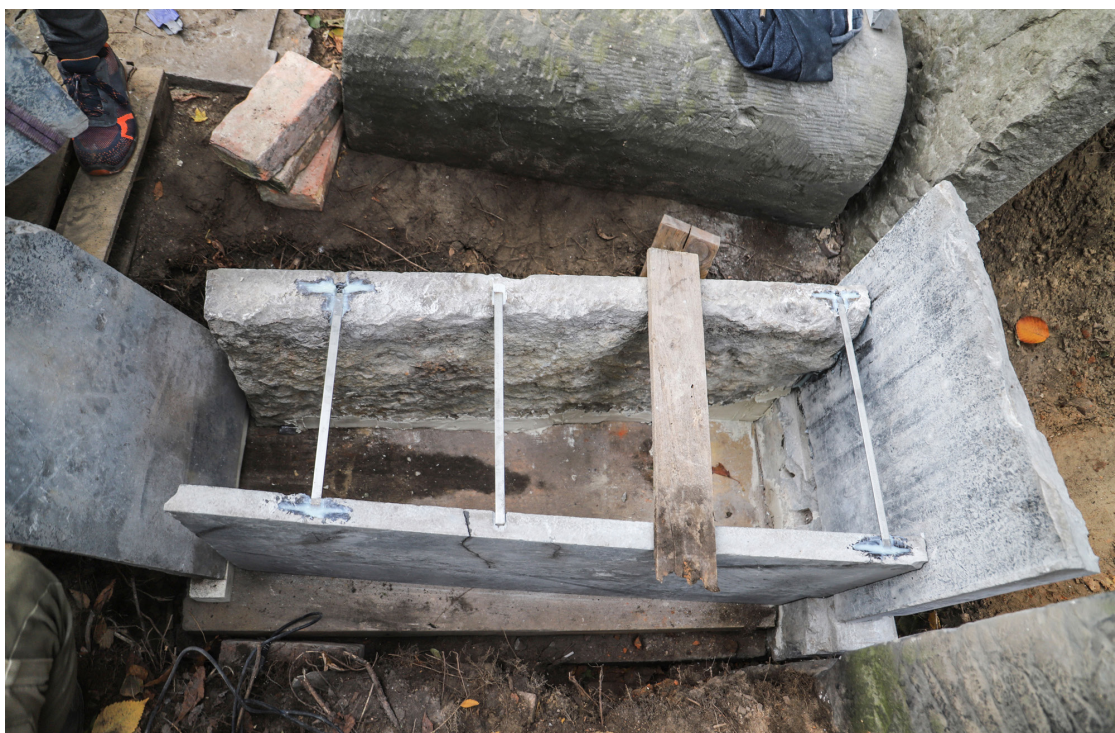
Fig. 4. Warsaw, Wola necropolis. Grave No. 428 – conservation work, visible sandstone foundation supporting stone kerbs on which a half-cylinder slab will be placed.
Photo: D. Pisarski.

(headers) facing each other, forming a casing. The centre was filled with brick rubble, tightly filled with lime mortar (Fig. 4). Assuming that the grave should have a depth of between 6 and 8 *te-fachim*,²⁷ i.e. about 60–80 cm, it can be assumed with certainty that this is the ceiling of the burial chamber containing the remains of the deceased. Above this brick 'floor' was a layer of sand about 10 cm thick, on which was laid a horizontal slab of sandstone also about 10 cm thick (Fig. 5). The slab supported a structure of an intermediate form, consisting of two rectangular stone kerbs along the longer sides of the chamber and a smaller slab enclosing the space to the west, on which rested a half-cylinder coping. The vertical stele was set on a separate, larger carefully shaped plinth.

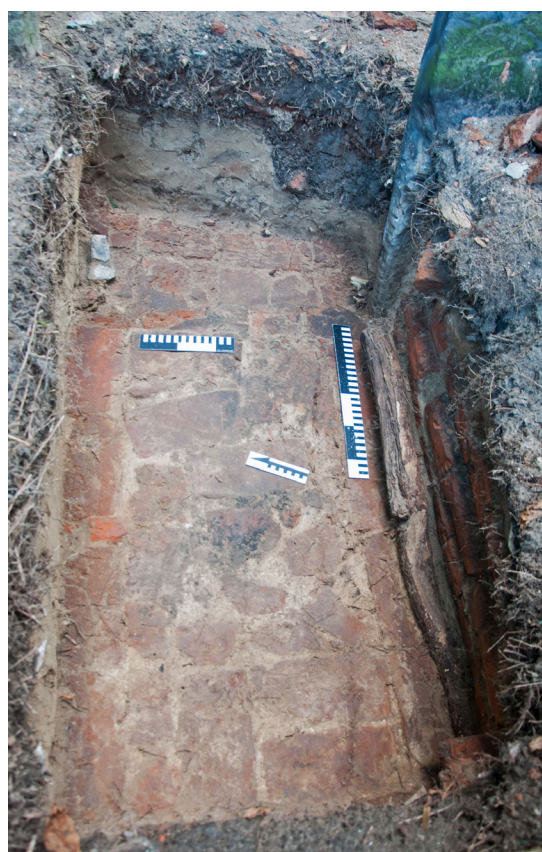
Fig. 5. Warsaw, Wola necropolis. The 'floor' of grave no. 428.
Photo: M. Sugalska.

elements, the soil had to be removed to a depth of approximately 50 cm. At this level, after cleaning the excavation trench, a carefully laid brick 'floor' measuring approximately 80×160 cm was discovered. The eastern part, where the matzevah is placed, consists of two parallel rows of bricks (stretcher face), and is located 5 cm lower than the western part. In the western part, the outline of the pit was lined with bricks with shorter sides

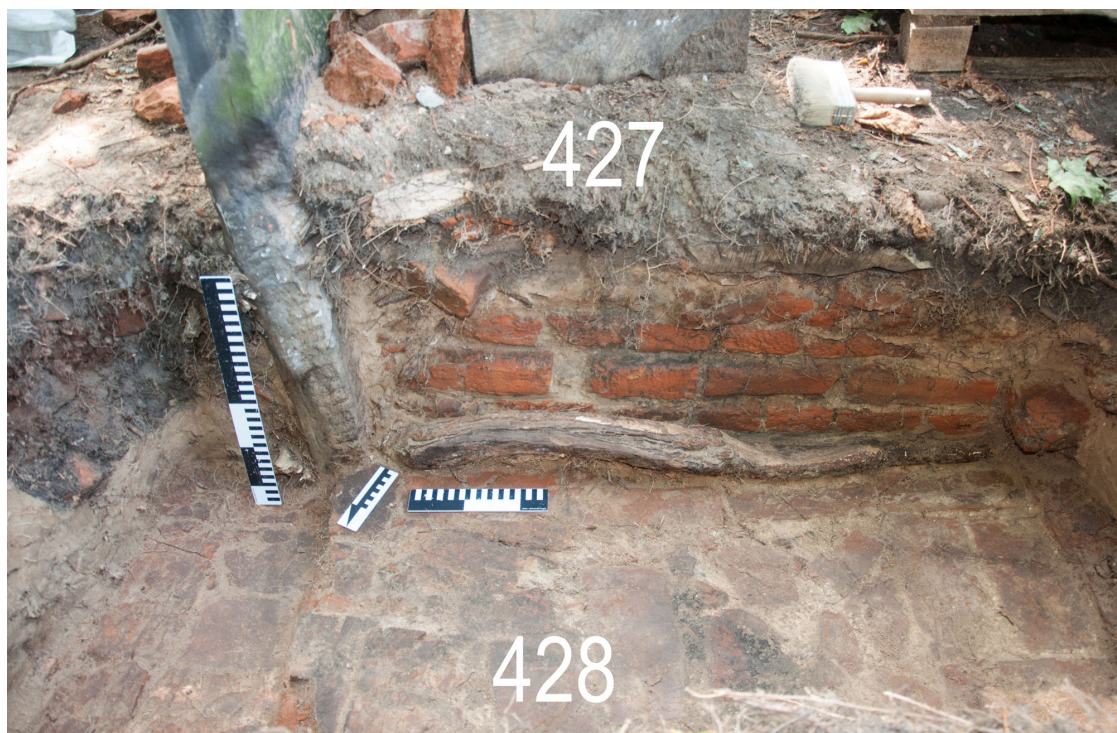
Fig. 6. Warsaw, Wola necropolis. Visible side wall of grave chamber no. 427 and part of the 'floor' of grave no. 428. Photo: M. Sugalska.

When cleaning the trench we discovered that on the south side, grave no. 428 closely adjoined grave no. 427 from 1847. This provided us with a view of the side wall of the chamber of grave no. 427, which shows different features. The chamber was lined with at least 5 layers of bricks, laid with their shorter sides (header faces) towards each other, in a Flemish bond. On top of these, just below a thin layer of litter, was a horizontally laid stone slab. The matzevah was dug into a depth of approximately 60 cm and its sides that were buried in the ground have not been thoroughly dressed and bear chisel marks (Fig. 6).

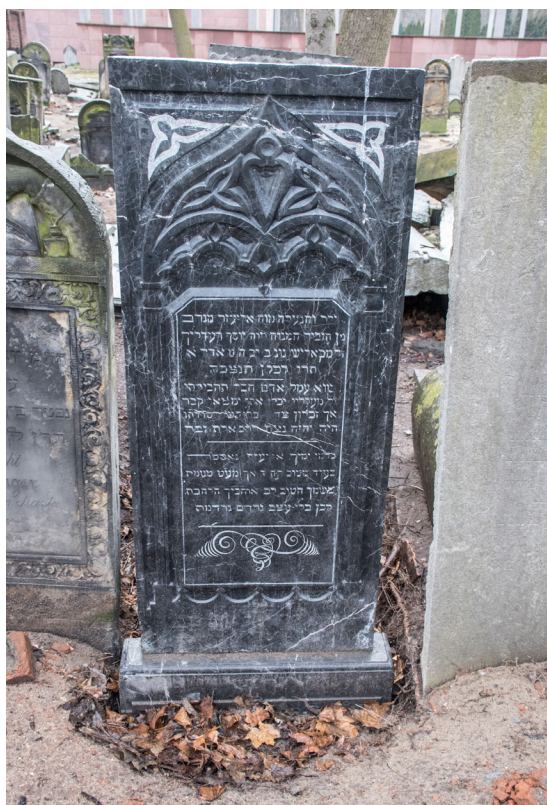
Fig. 7. Warsaw, Wola necropolis. Grave no. 428 – a matzevah after conservation. Photo: M. Sugalska.

The extensive damage to tombstone no. 428 in the form of a broken matzevah lying next to it and a shattered stone pedestal collapsed into the centre of the burial chamber required rapid conservation intervention. The restoration of the entire site (Figs. 1 and 7) required a deeper intervention in the ground. In order to remove all the stone

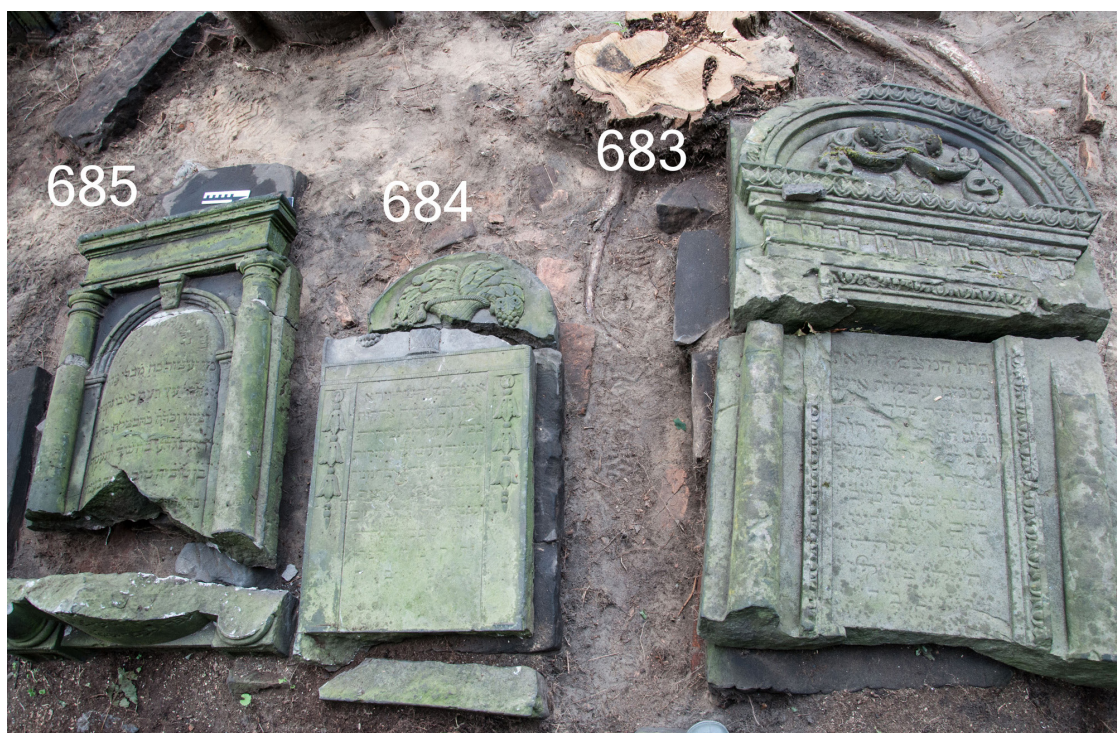
Fig. 8. Warsaw, Wola necropolis. Graves 683, 684, and 685 – the state before the start of the investigations.
Photo: M. Sugalska.

Graves nos. 683, 684, and 685 are located in the western part of the studied area and their state of preservation was poor. They all had broken matzevot, with 1/3–1/4 of their height preserved *in situ* (Fig. 8). During the archaeological work, the shattered elements were removed from the surface of the chambers so as to obtain information about their construction. In the case of all three graves, a stone slab, or a fragment thereof, was overlying an undetermined brick structure. When removing 10 cm of soil from the area in front of the face of the matzevot, we discovered fragments of yellow polychrome on the matzevah belonging to grave no. 685. The plinth of this matzevah is divided into two parts. The visible fragment of the upper part consists of three panels and the central panel bears an inscription with the date of death and a wish for eternal life, and the surrounding cymatium, a fragment of which was previously buried below the surface of the ground, has retained its intense yellow colour (Fig. 9). During the conservation work, i.e., the unearthing of the entire matzevah, the second part of the plinth decorated with a bas-relief in the form of five bannisters was discovered, which retained a white polychrome and the space between them an intense blue colour (Fig. 10). Below ground, the matzevah of grave no. 683 retained its two-part plinth. Its upper part is divided into three sections – the middle one is decorated with three fully preserved bannisters and two are preserved only partly. The side panels are

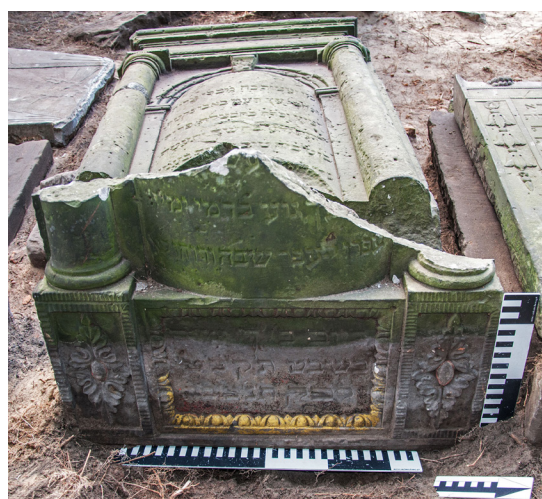
Fig. 9. Warsaw, Wola necropolis. Grave no. 685 – fragments of yellow polychrome on the plinth.
Photo: M. Sugalska.

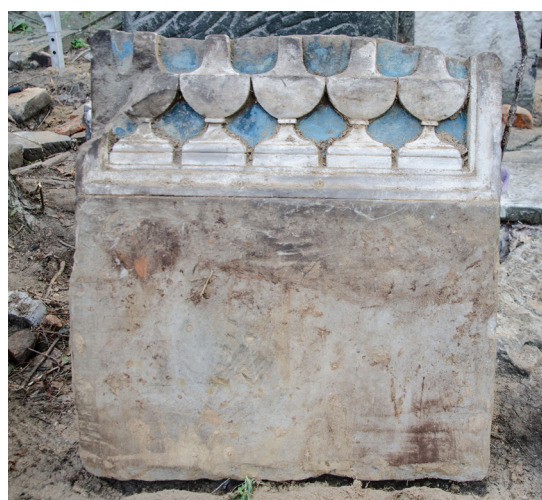
Fig. 10. Warsaw, Wola necropolis. Grave no. 685 – polychromed lower part of the plinth.
Photo: M. Sugalska.

in the form of rectangular pedestals for the bases of Doric columns. The lower part of the plinth in the form of a brick wall has preserved polychrome

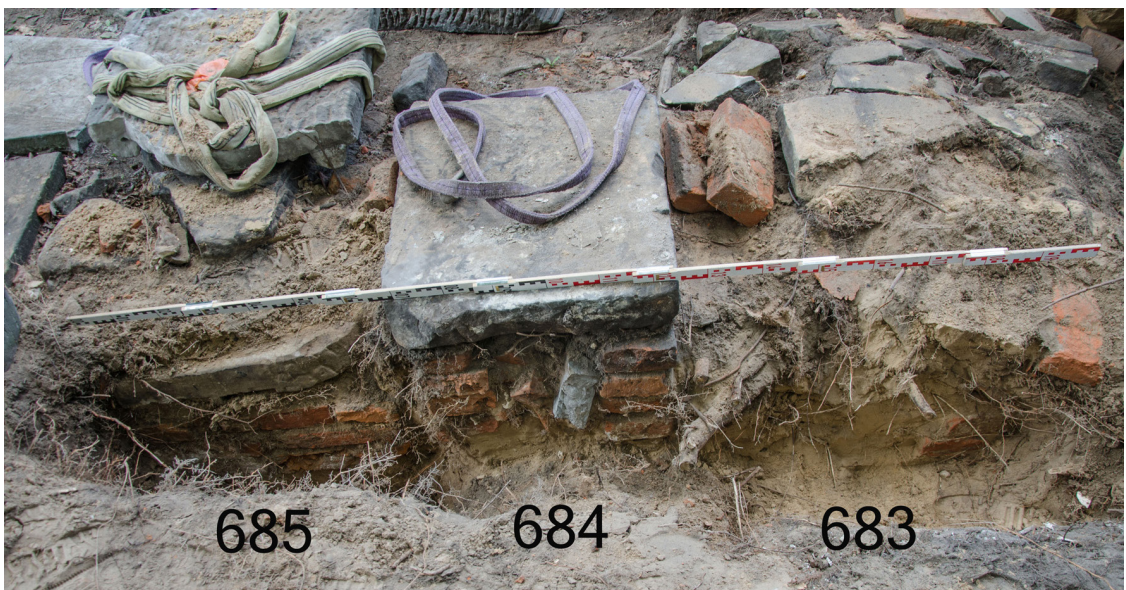
Fig. 12. Warsaw, Wola necropolis. Eastern profiles of the burial chambers of graves nos. 683, 684, and 685. Photo: M. Sugalska.

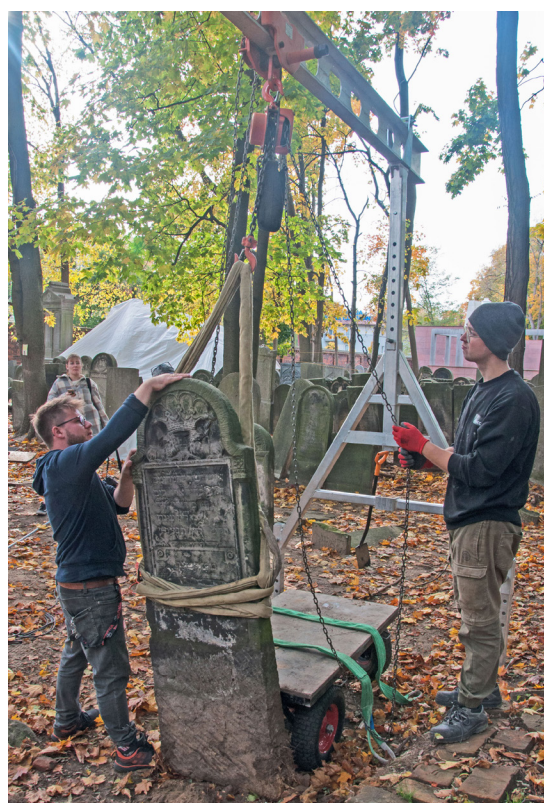
Fig. 13. Warsaw, Wola necropolis. Grave no. 20 – the removal of a matzevah. Photo: M. Sugalska.

Two further examples of monuments selected for conservation are single matzevot.²⁸ The preparation for conservation consisted only of digging the matzevot up from the east and removing them from the ground. After removing and cleaning the matzevot, we gained access to the eastern sections of the burial chambers.

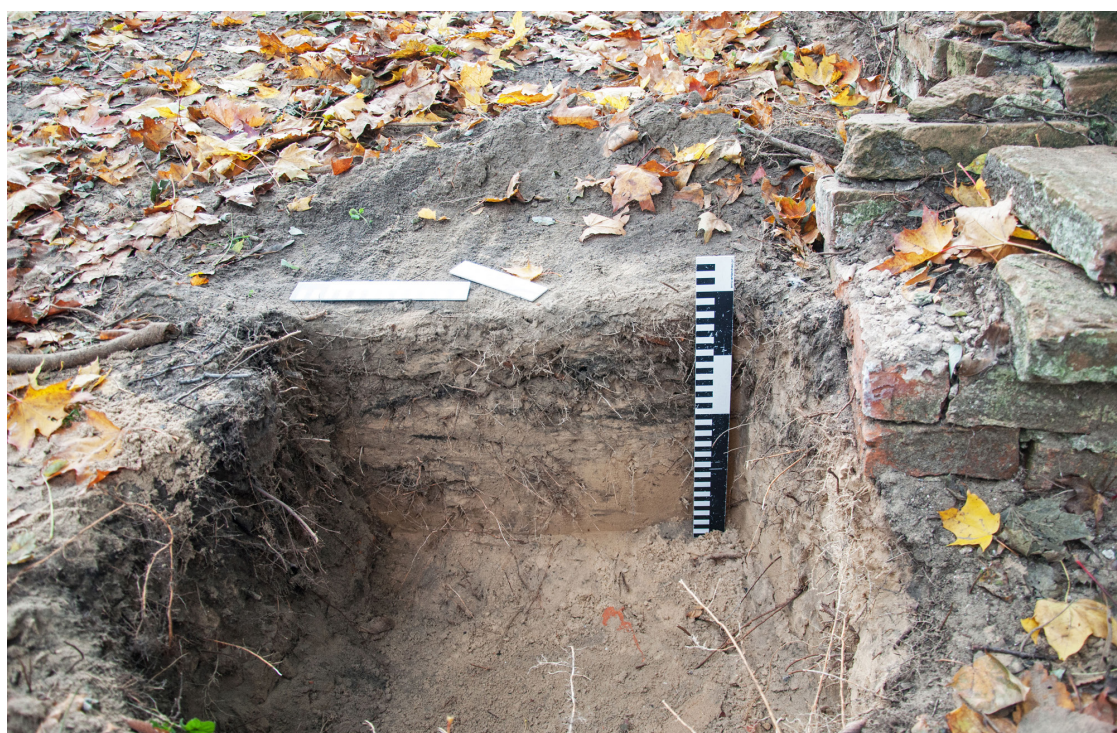
In this case, the burial chamber has no brick framing and there are no visible remains of wooden structures.

Fig. 14. Warsaw, Wola necropolis. Grave no. 20 – eastern profile of the chamber. Photo: M. Sugalska.

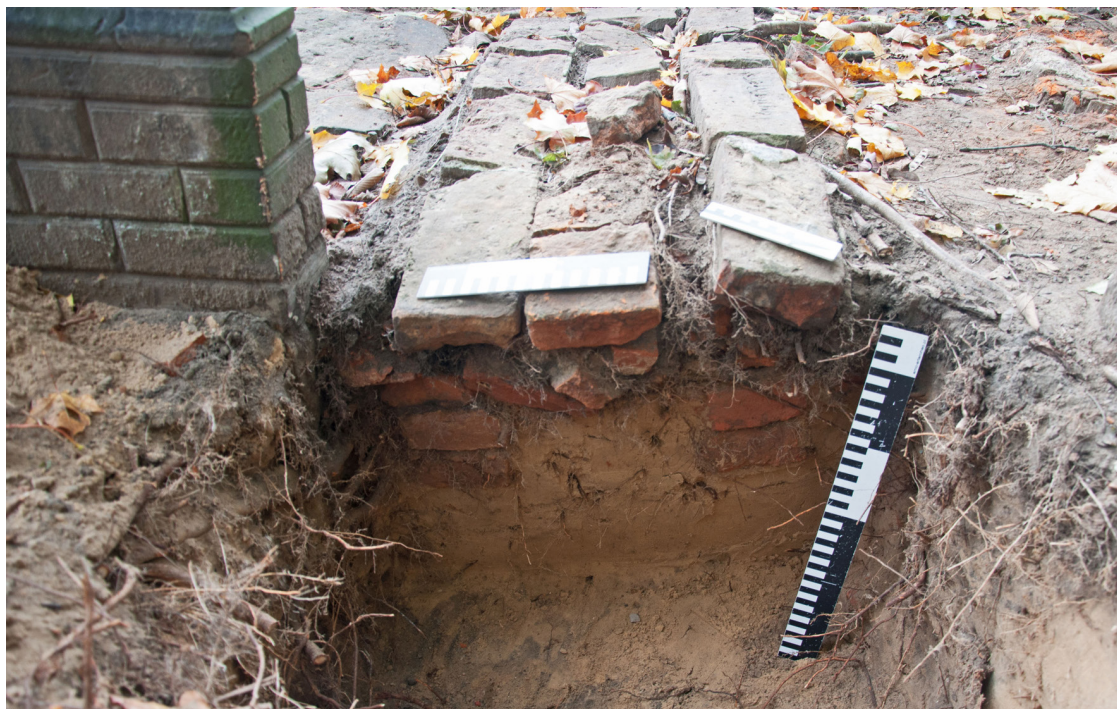
The burial chamber has bricks only in the ceiling section. From the top, the entire space of the burial chamber was lined with two layers of bricks, each layer consisting of three rows of bricks laid with their shorter sides (headers) to the matzevah; below, the chamber pit was secured with two layers of bricks laid only along the outline.

Fig. 15. Warsaw, Wola necropolis. Grave no. 20 – eastern profile of the chamber. Photo: M. Sugalska.

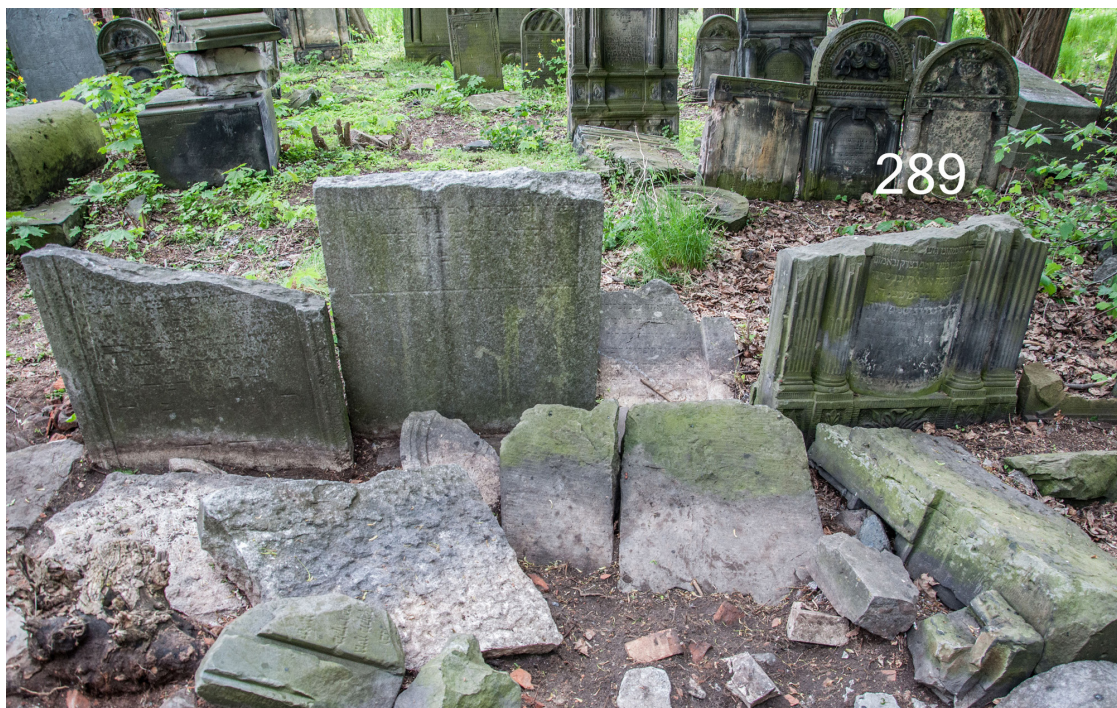
This is an example of a matzevah with elaborate and polychrome architectural decoration referring to the appearance of the temple façade. The area where grave no. 289 is located is characterised by more destruction, with all the matzevot and monuments in the area largely damaged. It is difficult to determine today whether this is the result of the activity of the densely growing trees or the result of warfare. For the most part, the matzevot in this area have been preserved up to 1/3–1/2 of their original height (Fig. 16), while the rest

Fig. 16. Warsaw, Wola necropolis. Grave no. 289 – state of preservation before conservation work. Photo: M. Sugalska.

of the matzevah. After conservation, the matzevah of grave no. 289 was deliberately buried so that the polychrome elements remain above ground.

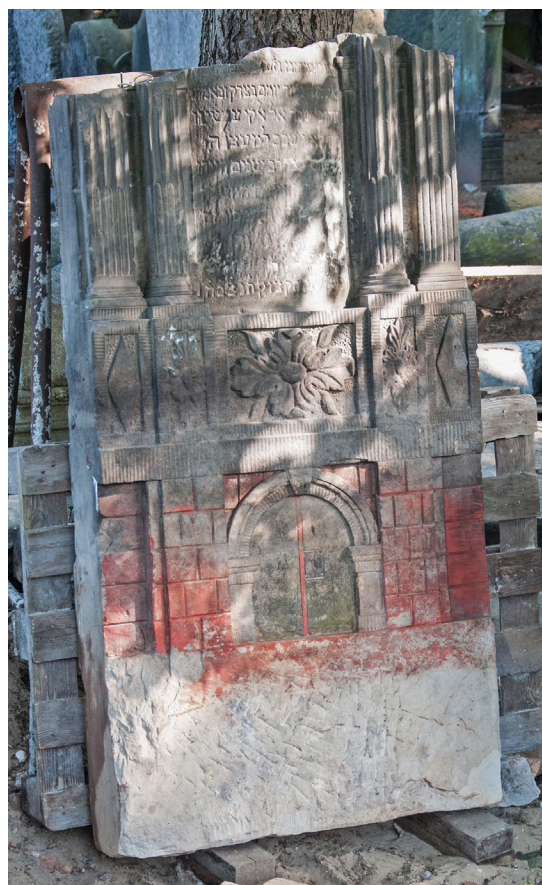
Fig. 17. Warsaw, Wola necropolis. Grave no. 289 – the matzevah after its removal from the ground. Photo: M. Sugalska.
