TOMASZ OLSZACKI*

CHURCH-HOSPITAL COMPLEX OF THE HOLY SPIRIT IN SZYDLÓW (LESSER POLAND) IN THE LIGHT OF FIELD RESEARCH AND AGAINST A COMPARATIVE BACKGROUND

This article presents the results of an archaeological and architectural investigation of the church and hospital complex of the Holy Spirit in Szydłów, one of the most interesting surviving examples of this type of layout in Poland. This study analyses the structural evolution of this site from the 16th to the 18th century, and reconstructs its successive development phases based on written sources, field studies and analysis of anthropological burials. Special attention was given to the complex's social and sepulchral uses, as well as its place against the background of hospital management in Poland and Europe. This study highlights the significance of future interdisciplinary studies of similar sites, which allow us to gain further insight into the transformation of the spatial disposition of hospital and sepulchral complexes that occurred between the Middle Ages and the modern period. They were marked by the narrowing of the religious sphere in favour of the secular functionalization of space and the separation of these onc

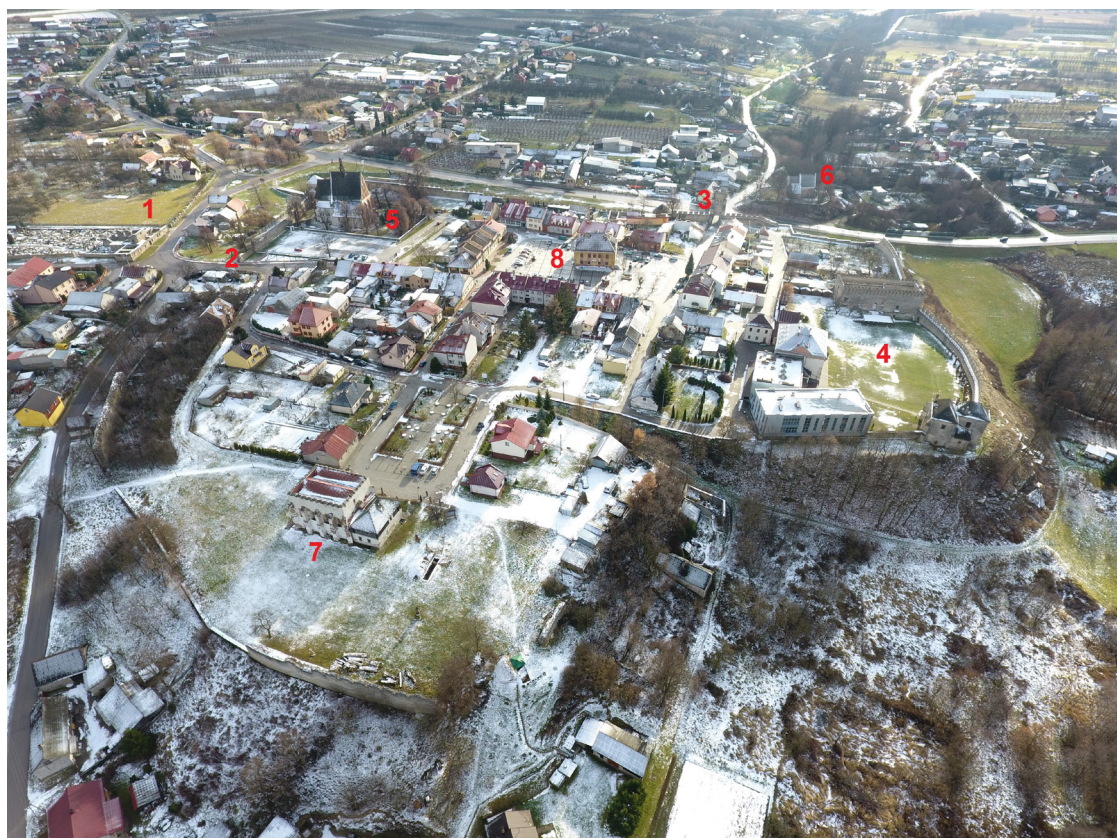
Fig. 1. Szydłów
– view from the north.
1 – Complex of the Holy Spirit with a modern cemetery from the east and the church garden to the south; 2 – The place of the former Opatów Gate; 3 – Cracow Gate; 4 – Royal Castle; 5 – Parish Church of St. Ladislaus; 6 – filial church of All Saints; 7 – Synagogue; 8 – City square, 2016.
Photo: M. Pisz.

Renaissance synagogue in the town's northern part¹ (Fig. 1).

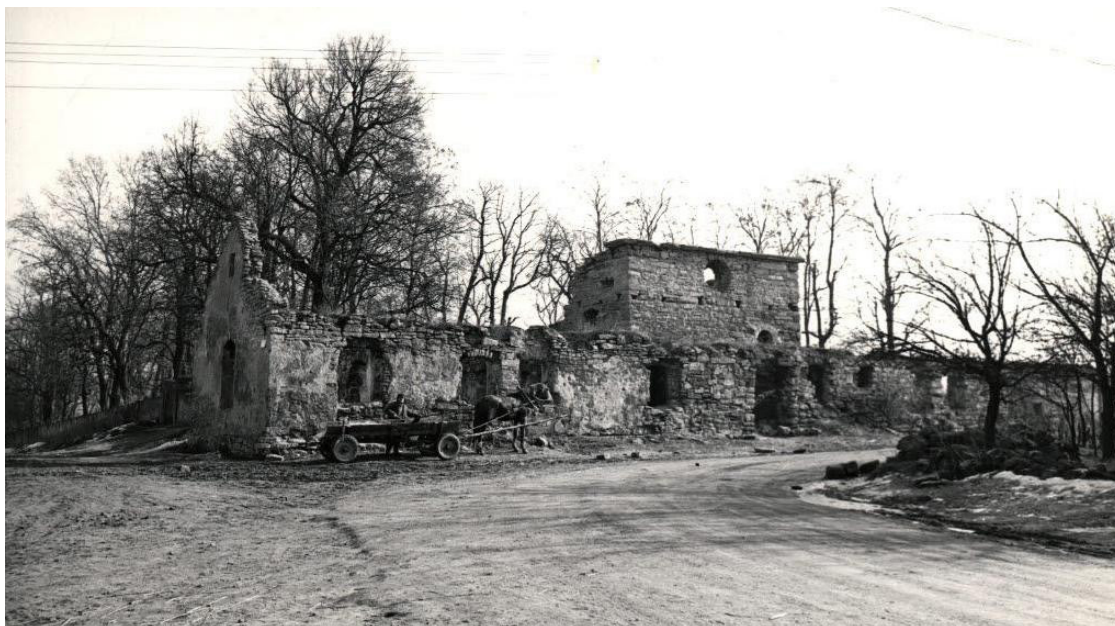
Fig. 2. Complex of the Holy Spirit in Szydłów, general view from the north-west, from the area of the former Opatów Gate, ca. 1970. Photo: Author unknown, Collections of the Szydłów City Hall.

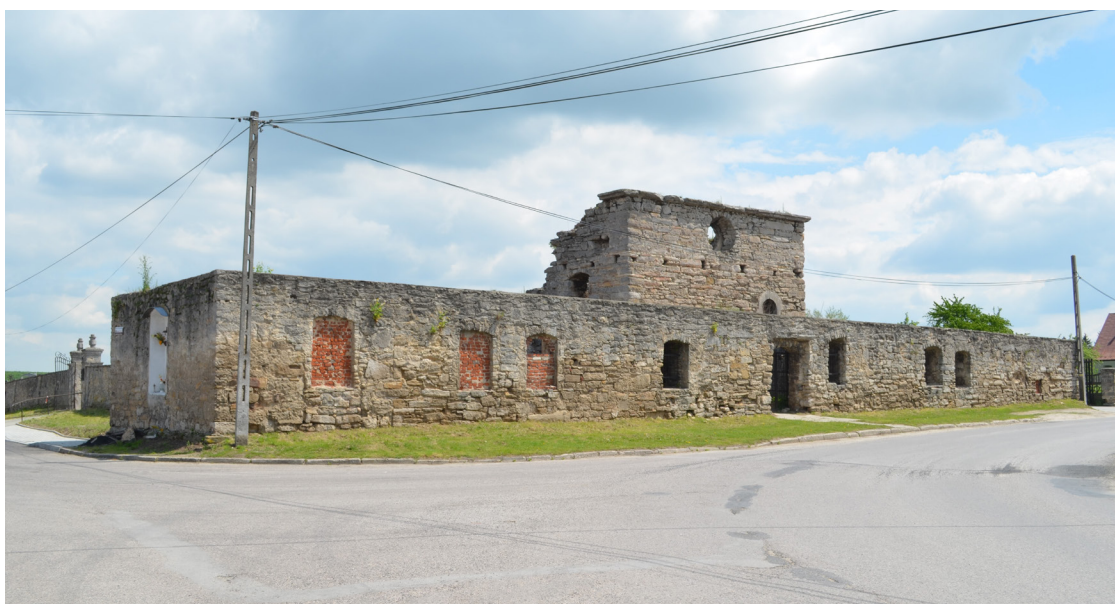
Fig. 3. Complex of the Holy Spirit in Szydłów, general view from the north-west, from the area of the former Opatów Gate. Condition before conservation, 2017. Photo: T. Olszacki.

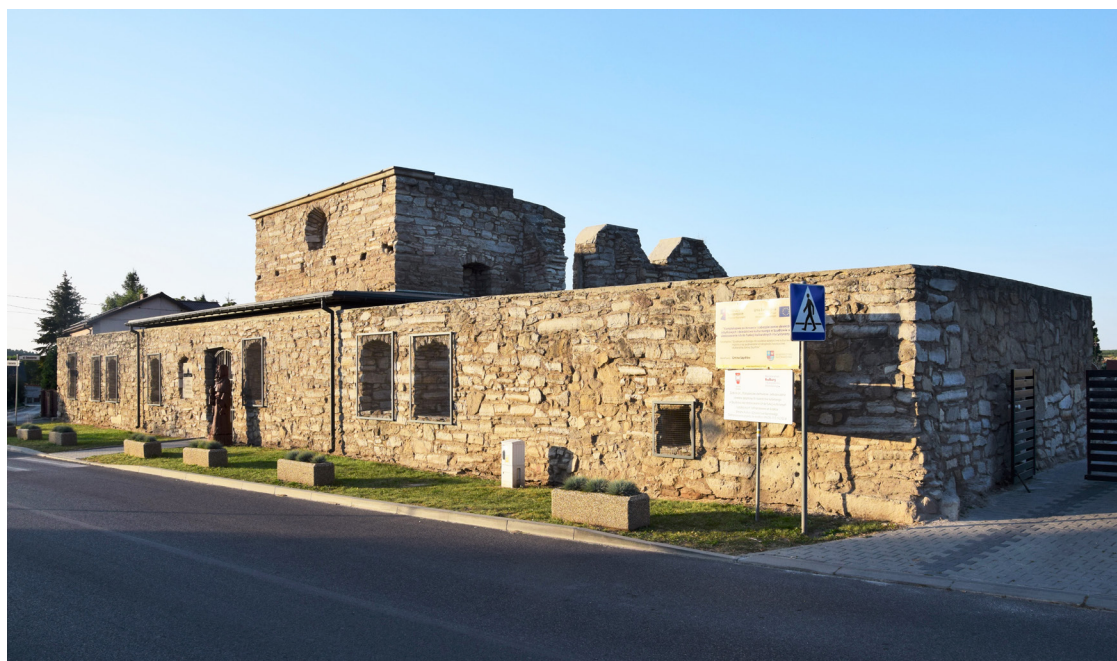
Fig. 4. Complex of the Holy Spirit in Szydłów, general view from the south-west. Condition after conservation, 2025. Photo: T. Olszacki.

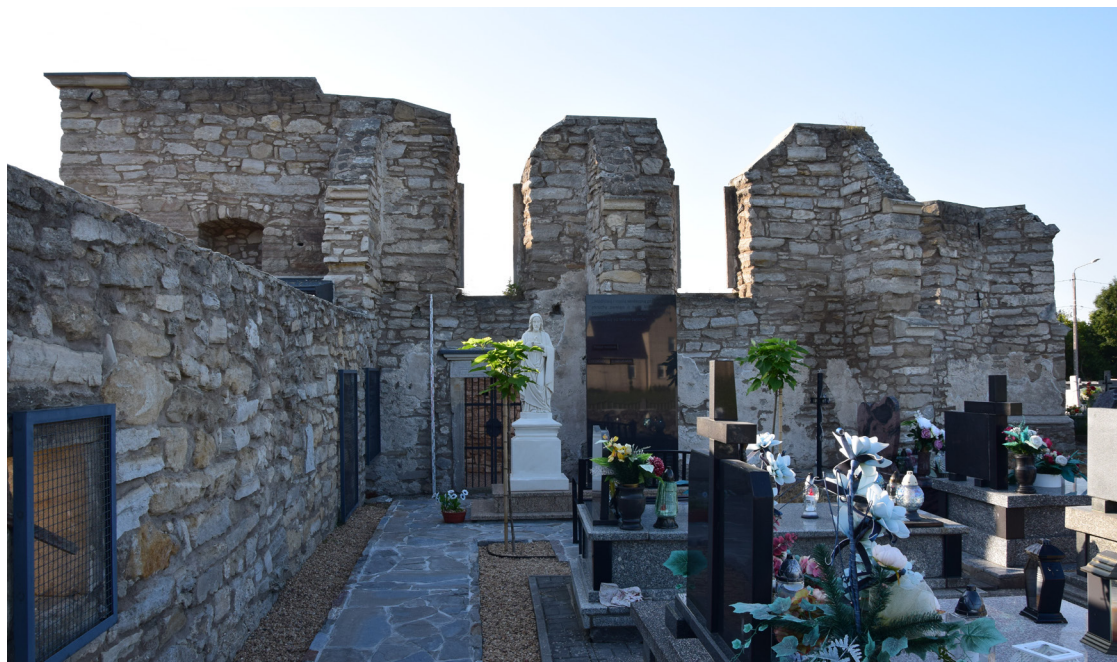
Fig. 5. Complex of the Holy Spirit in Szydłów, view of the hospital church from the south. Condition after conservation, 2025. Photo: T. Olszacki.

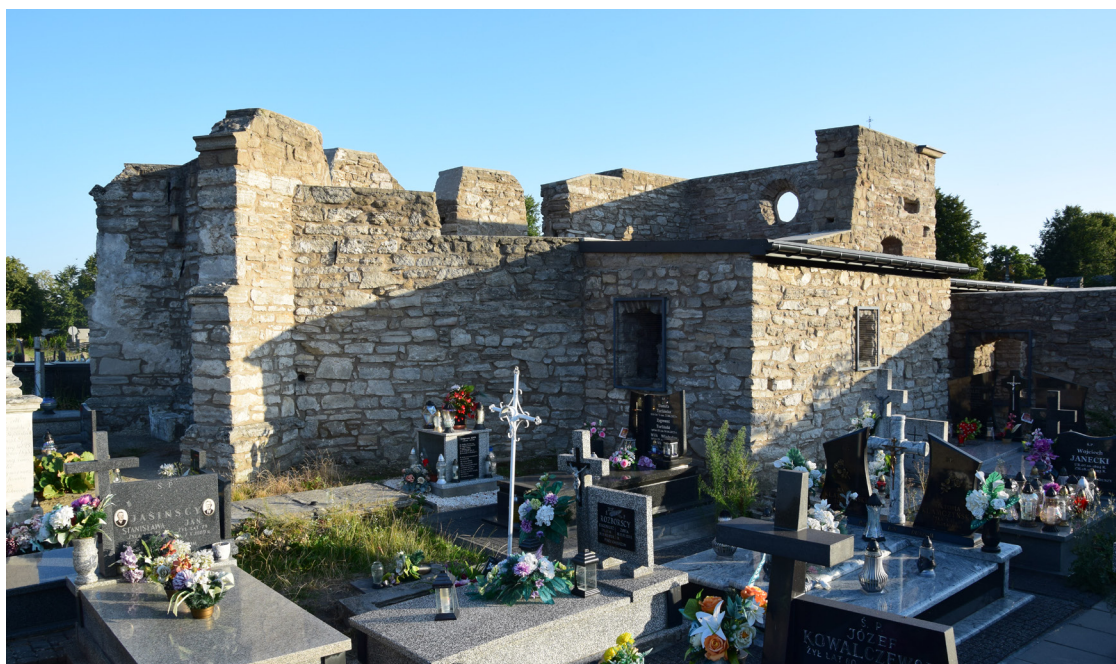
Fig. 6. Complex of the Holy Spirit in Szydłów, view of the hospital church from the north. Condition after conservation, 2025. Photo: T. Olszacki.

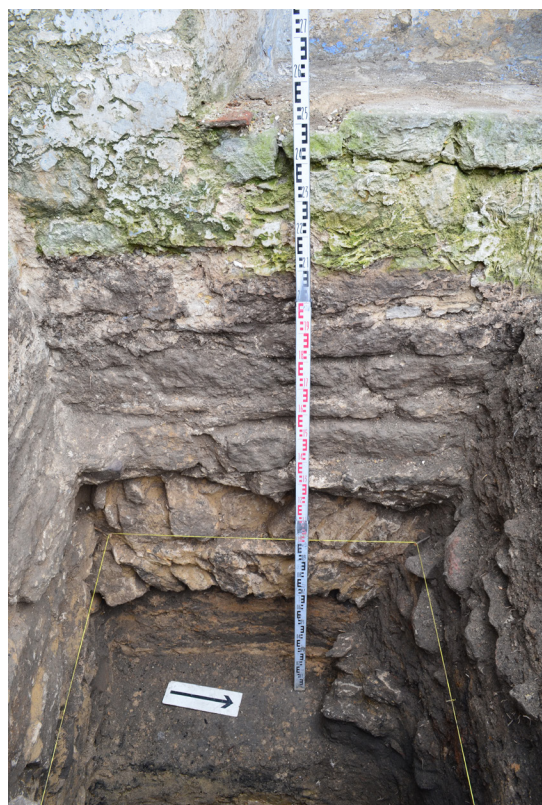
Fig. 8. Complex of the Holy Spirit in Szydłów, the north hospital wing, the archaeological trench 7/2017: an arcade foundation of the western wall of the hospital's north wing, 2017. Photo: T. Olszacki.

adjacent to it to the west, were identified only in the form of a rubble heap of their beam-built walls and postholes potentially related to the roof structure or internal divisions (trenches 1 and 5/2017) (Fig. 7:5, 7:5a). The arrangement of the burned beams in trench 5/2017 suggests that they were stacked on top of each other, and therefore the hospital was erected in a log or post-and-plank structural system. Their location makes it possible to guess the location of the north, outer wall of the building roughly in line with the inner face of the later north wall of the church nave. The fact of the occurrence of numerous “gothic” bricks (with heights of 81 and 110 mm) and brick rubble in trench 10/2018 and the location of these destructs in relation to other relics allow us to presume that the chapel and the hospital may have been separated by a firewall located on the north–south axis. The two subsequent usable levels of the hospital found in trench 5/2017 were at the levels of 257.10 and 257.30 m. There are indirect indications of the existence of a cesspit or well approximately 3 m north of the northern wall of the original hospital, which continued to function during Phase Two. This indicates a significant, localized deepening of the foundation at the node from the phase-three porch and north hospital wing (trenches 5 and 7/2017, where the wall foundation was found at 255.90 m a.s.l.), as well as the extension of the hospital's west wall from this node, with the use of – only at this site) of an arcade foundation spanning an old trench

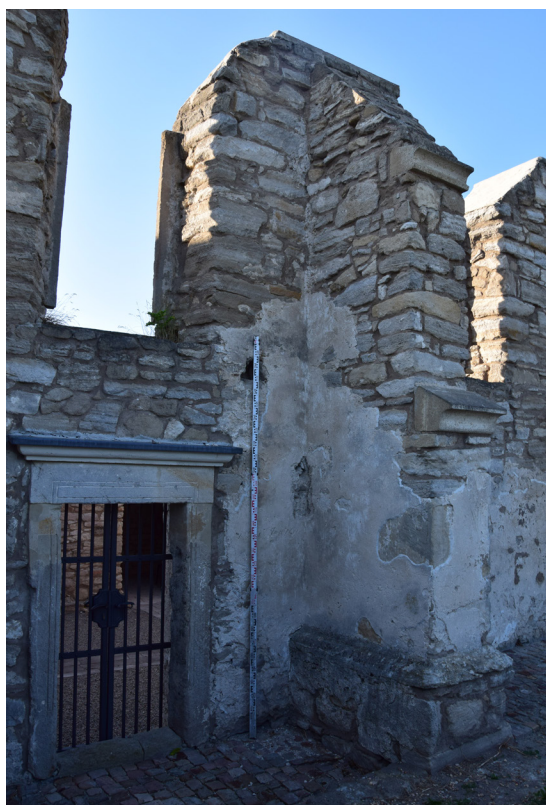
Fig. 9. Complex of the Holy Spirit in Szydłów, view of the hospital church from the south: side portal and buttress of the Phase Three. Condition after conservation, 2025. Photo: T. Olszacki.

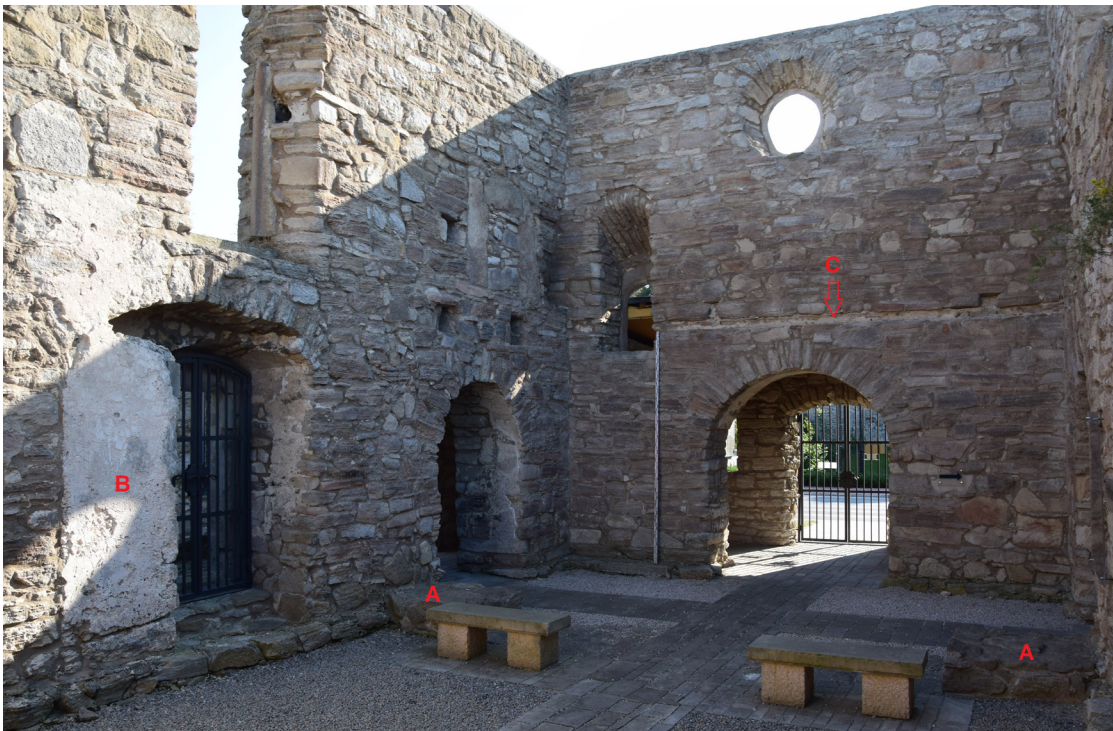
Fig. 10. Complex of the Holy Spirit in Szydłów, the nave of the hospital church: view towards the southwest with the western corridor of the ambulatory porch visible in the background:
A – fragments of the western wall of the church of the Phase Two;
B – partial bricking up of the panel niche of the Phase Two, and carving out a door opening in it in the Phase Three;
C – former floor level of the gallery. Condition after conservation, 2025.
Photo: T. Olszacki.

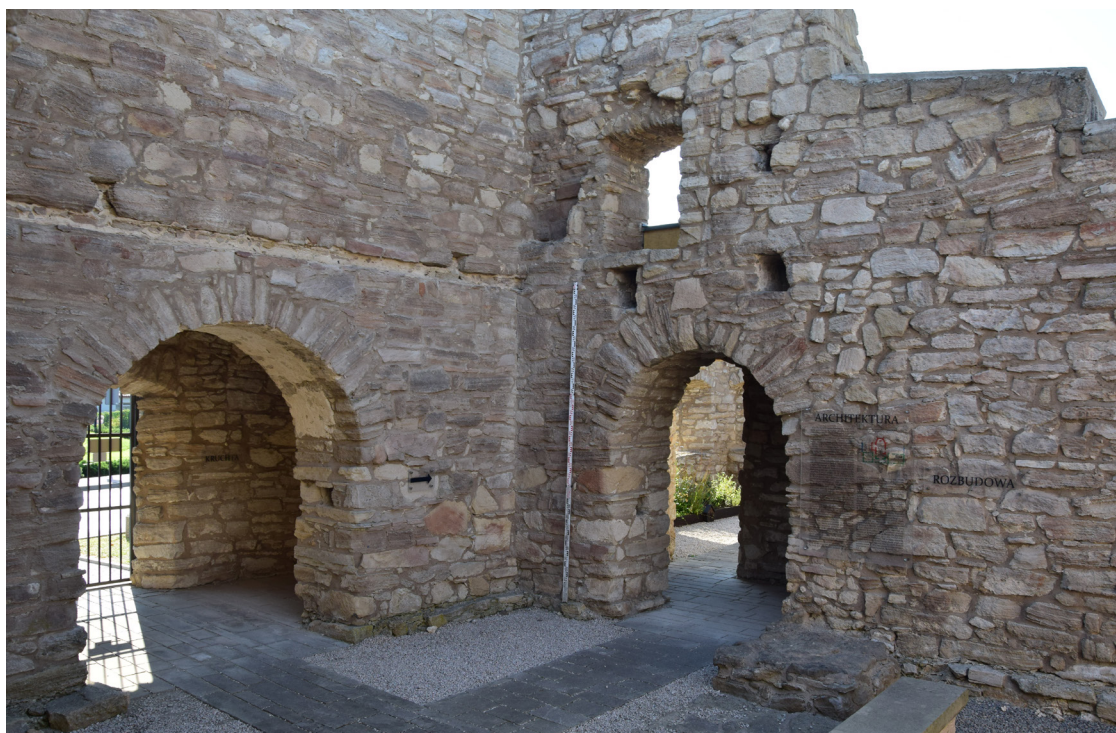
Fig. 11. Complex of the Holy Spirit in Szydłów, the nave of the hospital church: view towards the southwest, on the left side the western corridor and on the right side north corridor of the ambulatory porch. On the right side in the background Patients' room in the north hospital wing. Condition after conservation, 2025. Photo: T. Olszacki.

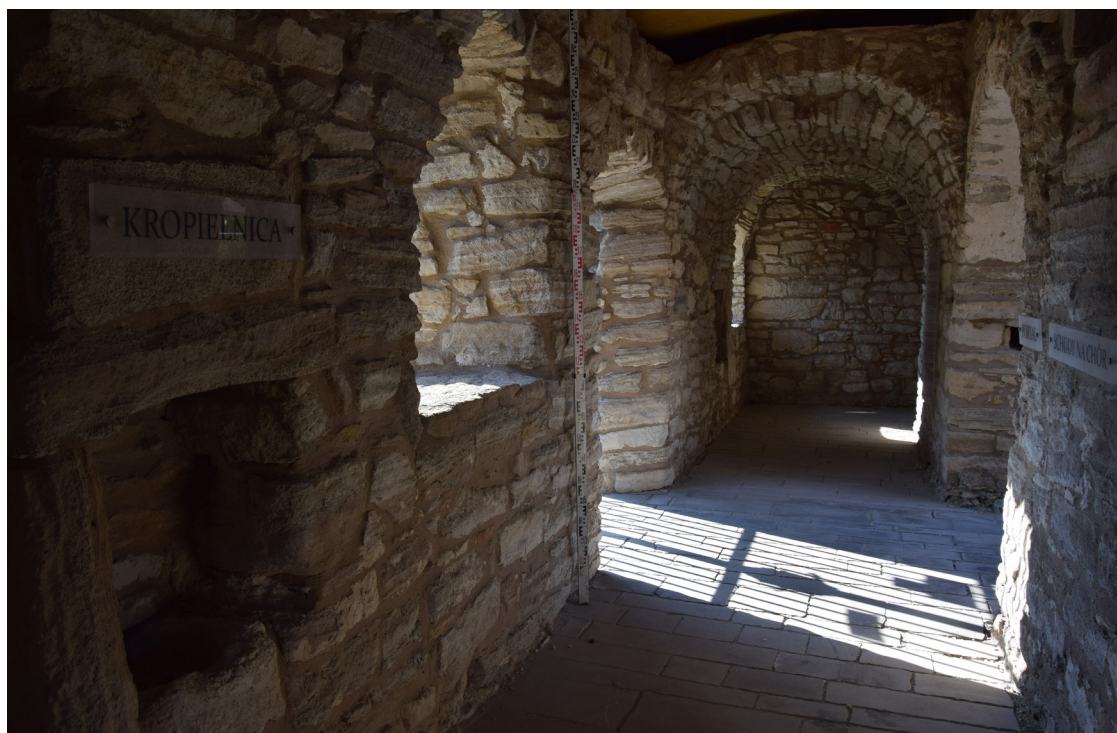
Fig. 12. Complex of the Holy Spirit in Szydłów, the western corridor of the ambulatory porch from the south side. Condition after conservation, 2025. Photo: T. Olszacki.

of the porch was fully connected to the corners of the two hospital wings, while its foundation was (with the exception of the corner with the northern wing of the hospital – as mentioned in the analysis of Phase One) at about 256.80-256.50 m a.s.l., with a slope towards the north. This wall contained the main entrance to the entire complex, located in the axis of the main entrance portal to the church. The porch was also the circulation zone between the two wings of the hospital and connecting the hospital with the garden and cemetery zone, through the northern exit (at the point of contact with the sacristy) and the southern exit (where the church is connected to the southern wing). The width of the western corridor reaches 1.95 m, the northern corridor ca. 1.5 m, and the narrowest southern corridor ca. 1.25 m. The original usable level of the cobblestone-lined porch was at about 257.35 m a.s.l. On either side of the main entrance there was a window opening and behind it two niches with segmentally arched vaults (about 1.95 m wide with a height of about 2.35 m) with straight corners located at the corners with the hospital wings. Originally, the interior of the porch was not vaulted, and was probably covered by an open roof truss. Above the south arm of the porch was a pulpit roof (the sockets of its rafters are preserved in the west facade of the church), and it merged with the gabled roofs over the hospital wings (Fig. 12).³²

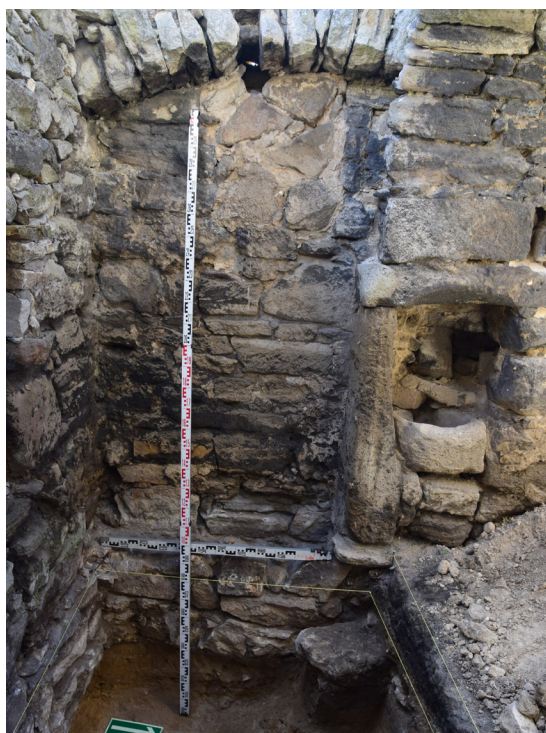
Fig. 13. Complex of the Holy Spirit in Szydłów, the archaeological excavation 7/2017: corner of the hospital's southern wing and the western corridor of the ambulatory porch with stoup (Phase Four) introduced into the north part of the niche of the Phase Three, 2018. Photo: T. Olszacki.

The U-shaped ambulatory porch (Polish: *kruchta obejściowa*) was planned as a practical, multifunctional, circulation space. As shown by excavations 5/2017 and 11/2018 (Fig. 13), the western, front wall

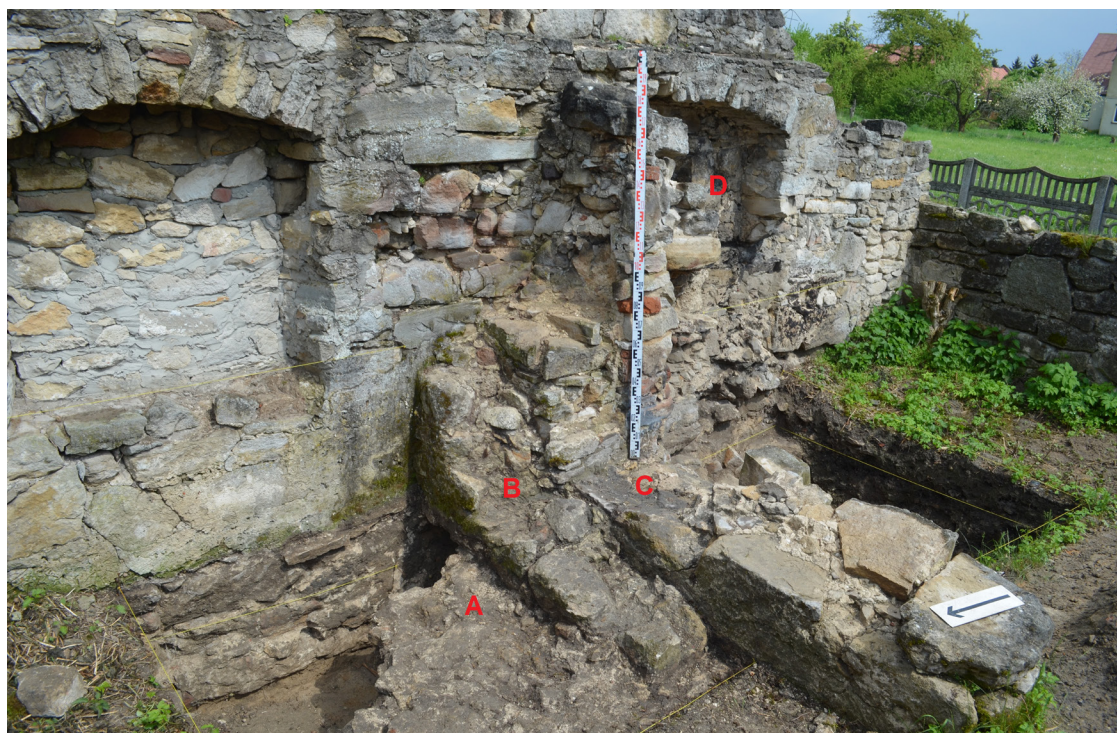
Fig. 14. Complex of the Holy Spirit in Szydłów, the south hospital wing, the archaeological trenches 2 and 9/2017: A – Hearth inside the Phase Two hospital; B – Fireplace inside the hospital of Phases Three and Four; C – Shaft between hearth and fireplace of Phases Three and Four; D – Small window-vent in the hospital's east wall of the Phase Two, later bricked up, 2017. Photo: T. Olszacki.

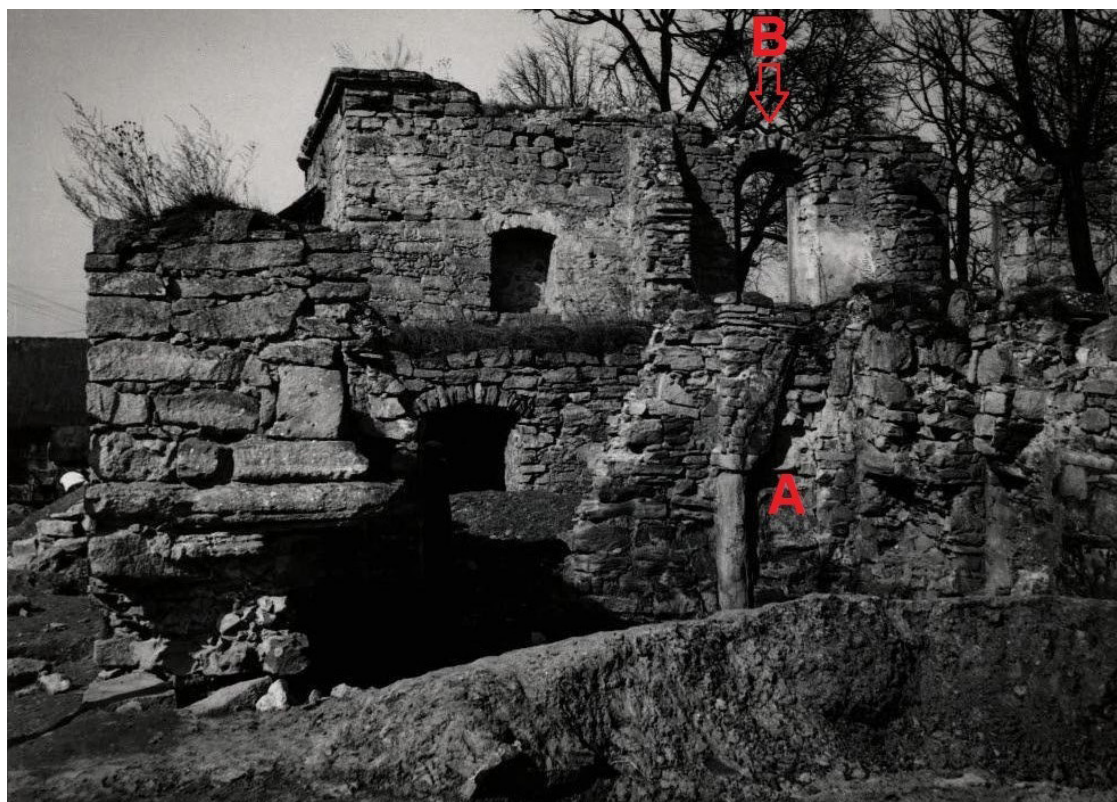
Fig. 15. Complex of the Holy Spirit in Szydłów, view from the south. In the foreground south hospital wing, hospital church in the background: A – The pillar and smoke duct of the hearth (Three and Four Phases); B – The finial of the hospital church window, ca. 1970. Photo: Author unknown, Collections of the Szydłów City Hall.

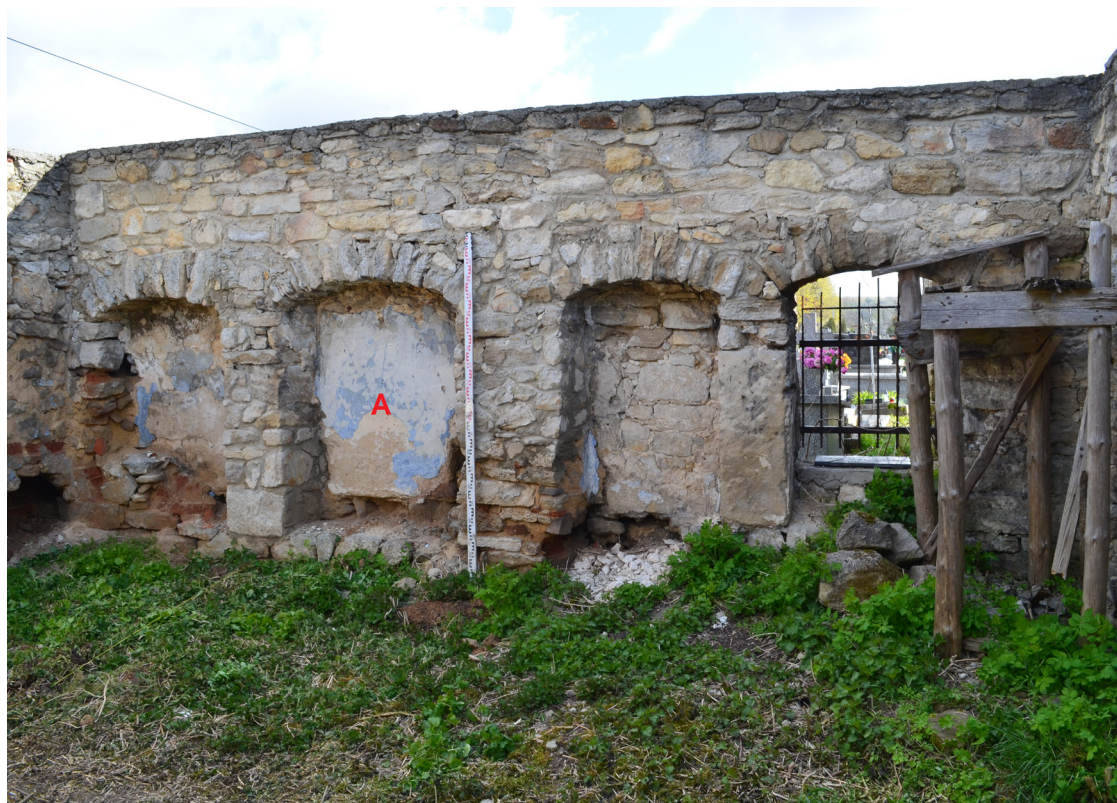
Fig. 16. Complex of the Holy Spirit in Szydłów, the north hospital wing, east wall of the patient's room: A – Former doorway to the latrine, 2017. Photo: M. Cichocki.

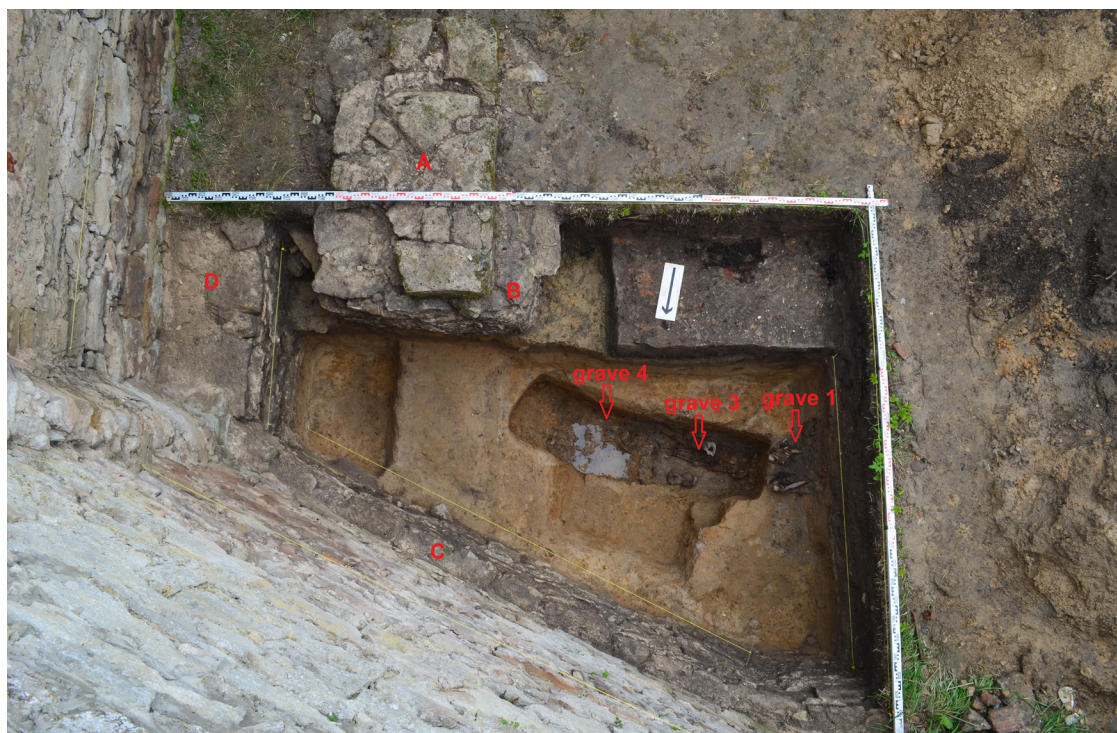
Fig. 17. Complex of the Holy Spirit in Szydłów, hospital church – chancel, view from the north of the archaeological trench 1/2017 while exploring the graves: A – The stipes of the altar; B – Foundation of the stipes; C – Foundation of the northern wall of the chancel; D – Foundation of the eastern wall of the chancel, 2017. Photo: M. Cichocki.

caring for a hospital was undoubtedly continued in front of the altar, but these burials were not numerous. The aforementioned Phase One grave was intersected by a deeply entrenched burial of *infans one* laid in a trapezoidal coffin, with its head to the west, 0.8 m away from the altar stipes (grave 3) (Fig. 17).

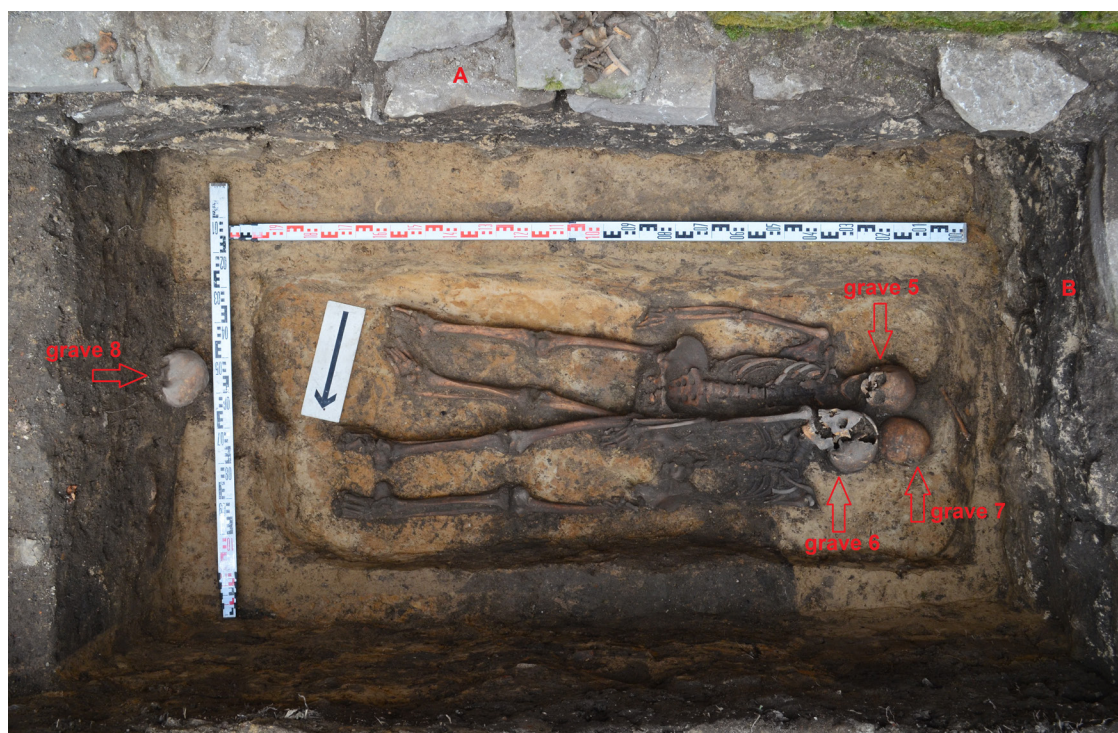
Fig. 18. Complex of the Holy Spirit in Szydłów, the nave of the hospital church, view from the north of the archaeological trench 8/2017 while exploring the graves. A – Foundation of the southern wall of the church; B – Foundation of the western wall of the church (Phase Two), 2017. Photo: M. Cichocki.

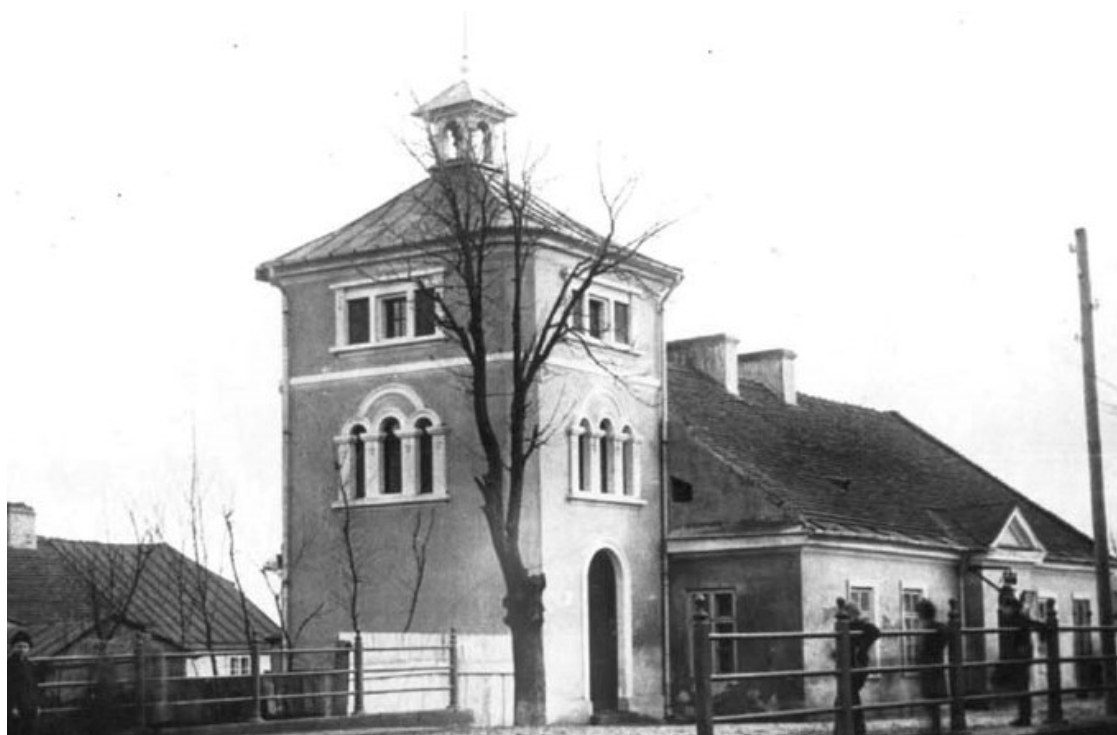
Fig. 20. The non-existent chapel-hospital complex of st. Trinity in Piotrków Trybunalski, before 1939, Photo: private collections. Source: <https://www.piotrkowski24.pl/>
