UTILITY STRUCTURES OF THE TRIPOLYE CULTURE

Chernovol D. 2021. Utility structures of the Tripolye culture. *Sprawozdania Archeologiczne* 73/2, 47-66.

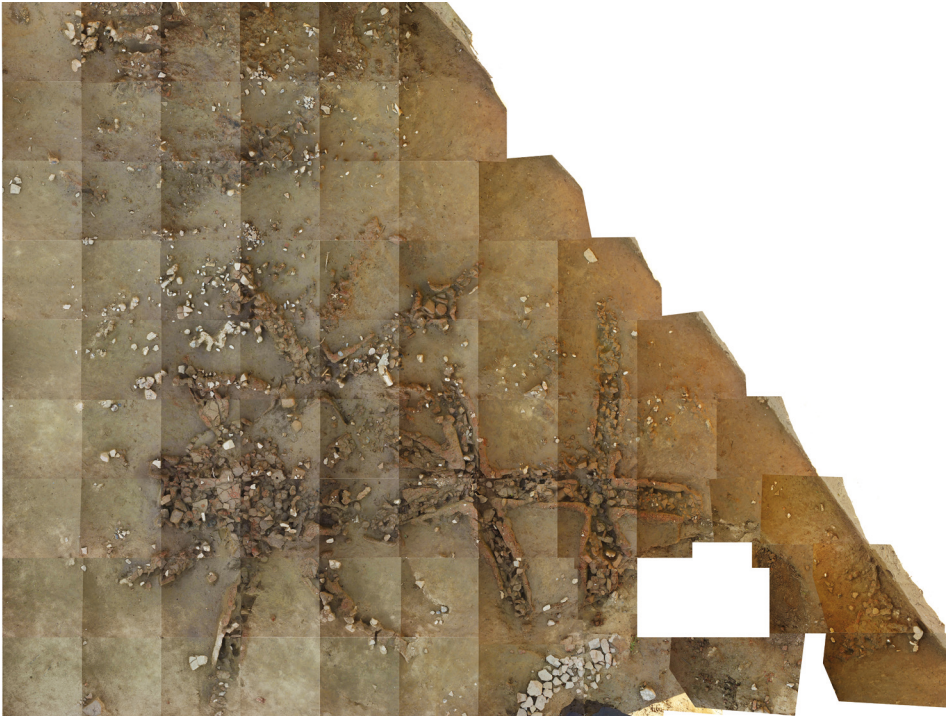
Fig. 3. Ozhevo-Ostrov. Kiln and system of ditches between Houses 1 and 2. Illustrated by D. Chernovol

Other economic activities reflected by small buildings were also noted. For example, a complex probably associated with the processing of leather was investigated at the settlement of Ozhevo-Ostrov. A kiln used for the firing of limestone was placed in the centre of this complex. Narrow ditches linked this kiln to some pits that were located on the lower storey of the houses placed nearby. The width of the ditches reached 0.4 m, while their depth reached 0.3 m. Clay was attached to the walls and bottoms of these ditches. Later on this clay was fired, probably, as a result of burning the wood inside them in order to obtain ash. The mix composed of calx and ash was moved to the pits and then they were filled with water. The mix was used for keeping the leather in it for easier removing of pelage (Fig. 3).

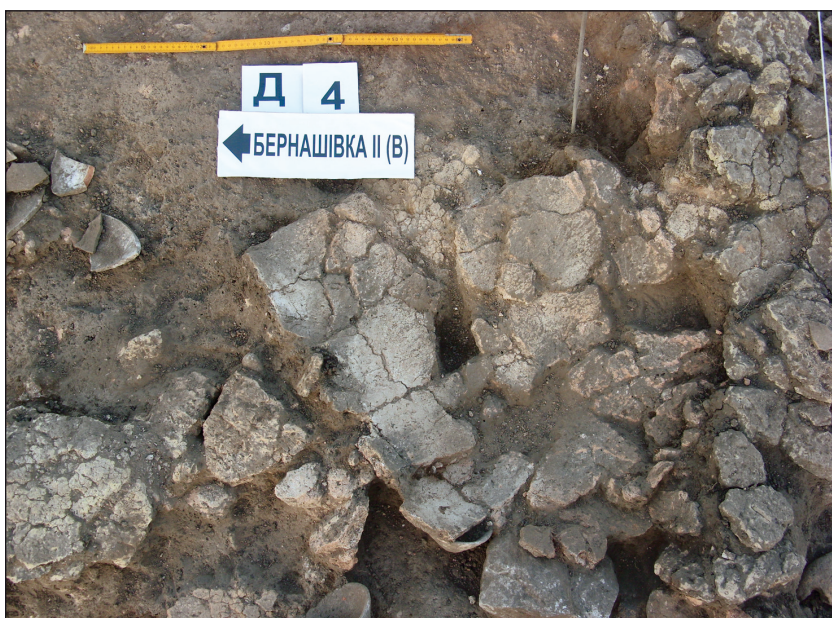
Fig. 6. Bernashevka II. Ploshchadka 8, container vessel. Photo by D. Chernovol

Interior structures, *i.e.* three installations preserved fragmentarily, on the lower storey of this building were mainly located along the left long wall. One installation had walls. The one near the wall opposite the entrance was linked to a pit, partly located inside the building and partly outside it. This raises questions about the construction of the wall and its existence at all. A helmet-shaped lid covering some ochre and fragments of a container vessel were found in this pit (Fig. 6).

In general, fragments of seven container vessels were found in the lower storey of this building. Fragments of their walls were mainly found together with fragments of burnt daub, but the bases were located *in situ* on the ground floor. This was the first find of container vessels at the settlements of the Petrenskaya group. Previously, such vessels were associated only with Tomashovskaya group houses (*e.g.* Kruts 2003). Unlike the Tomashovskaya group, container vessels of a pear shape, these finds had a mortar shape.

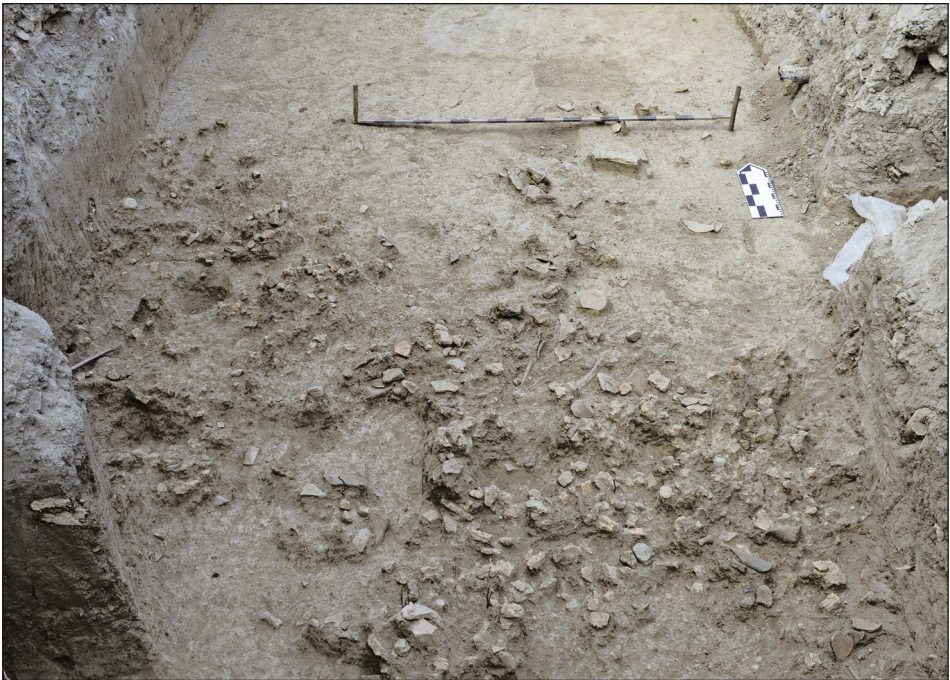
Fig. 7. Kamenets-Podolskiy. The wall of the workshop. Photo by D. Chernovol

According to the finds, the utility structure in Kamenets-Podolskiy was associated with copper processing (Figs 7 and 8; Czernowol 2017). Daub fragments had only imprints of the thin sticks to which it was applied indicating their relation to the walls. Daub fragments were located in a line that was 2 m width. Therefore, we are dealing with the single storey building with a ground floor. This utility structure was only partly investigated, because of its location in the modern city of Kamenets-Podolskiy. The remains of this building are partly covered by the periphery of a house block. Therefore, it is not possible to reconstruct the size of this utility structure. However, the excavated part allows us to characterise the function of this building. This ploschadka belongs to the Petrenskaya group dated to the Tripolye CI phase. Considering other excavation-sites in this part of a city, the workshop was probably located in the internal part of the settlement structure.

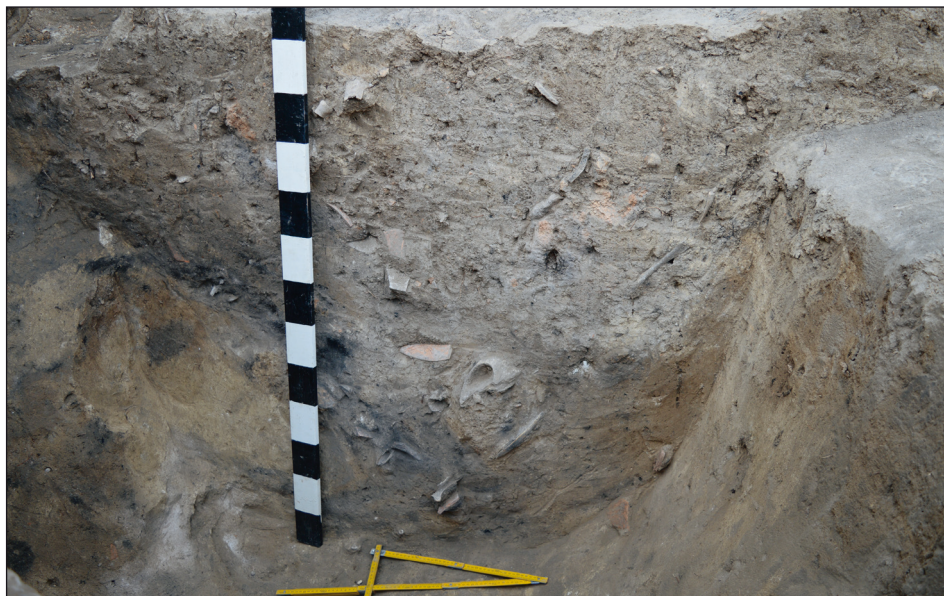
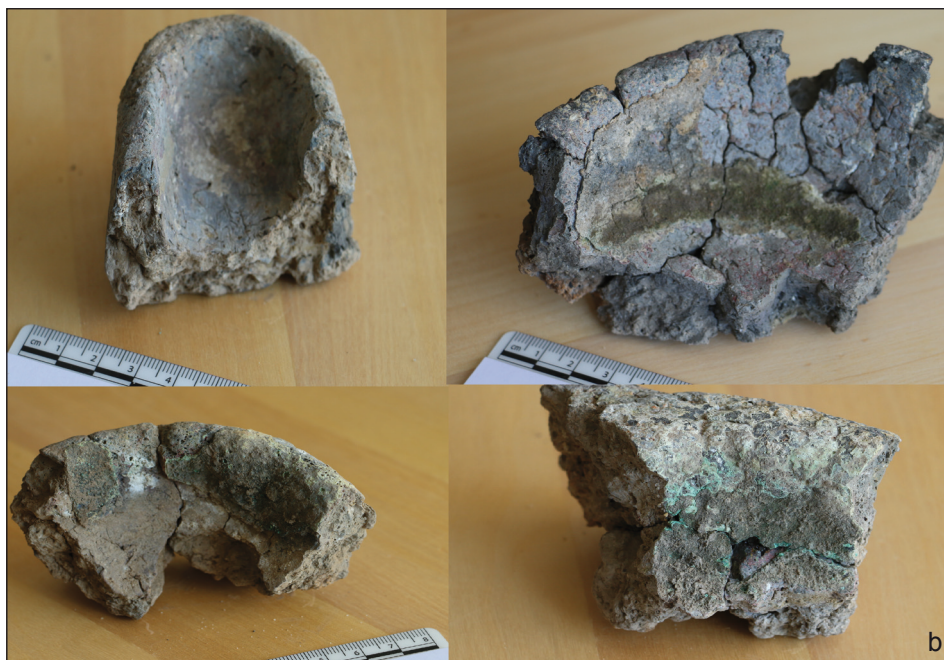
Fig. 8. Kamenets-Podolskiy. Profile of the pit in the workshop (a) and the fragments of smelting bowls (b)
Photo by D. Chernovol

A pit of a size of 2.1×2.9 m and with a depth of 1.2 m was investigated below the remains of the wall (Fig. 8). Its filling included numerous remains related to copper casting. More specifically, 40 fragments of crucibles, including 18 fragments of rims with copper on them were found (Fig. 8). Such fragments were also found on the ground floor of the building. One fragment of a casting mould was also found below the remains of the wall (Fig. 7). The crucibles were made of clay with organic admixture. They were partly turned to a ceramic slag because of the affect of heating. Most probably, this pit belonged to the structure of a workshop. It had a flat bottom and a step on the wall (maybe a place where the craftsman was sitting). A shallow depression of a depth of 0.1 m was found near the opposite wall. The walls were quite steep. It should be noted that Tripolye Culture pits are mainly lens-shaped in section. They were initially used for the extraction of clay and then turned into garbage pits. The pit in the workshop also was turned to a garbage pit, but the change in its function corresponds to the time after destruction of the walls.

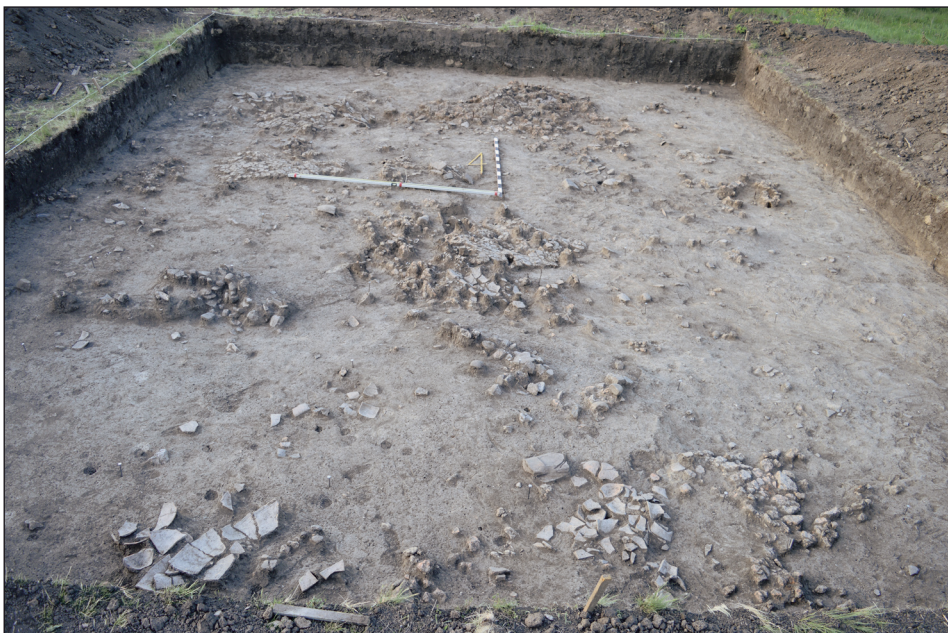
Fig. 9. Voloshkovo 6 (Gorby). Ploshchadka 2. Photo by D. Chernovol

Along the long walls of Ploschadka 2, large fragments of burnt daub with imprints of wattles of a diameter of 5 cm were found. The thickness of these fragments reached 10-15 cm. All the daub fragments are associated with walls. The back wall was highly affected by heat reaching a temperature of $1,000^{\circ}\text{C}$ (the latter is reflected by the vitrified daub). Probably this utility structure was subdivided into two rooms, *i.e.* an entrance room and the working space. This assumption is supported by the fragments of daub located in a line that is perpendicular to the long walls of the building. Besides this, the installation located nearby on the long axis of the building may indicate the entrance to the working space. If this assumption is true, then the size of the entrance room was 4×6 m, and the size of the working room was 5.5×6 m. Generally, such an organization of space is known for the lower storey of the buildings of type B (see below; Chernovol 2012; 2013). Interior details in such buildings were located closer to the back wall.

Five clay installations were discovered on the ground floor. Two of them were located along the left long wall, one near the back wall, one to the right of the entrance, and the other one in the centre of the structure. Four of these installations were preserved in fragments, while installation 3 near the back wall had interesting construction details. It had

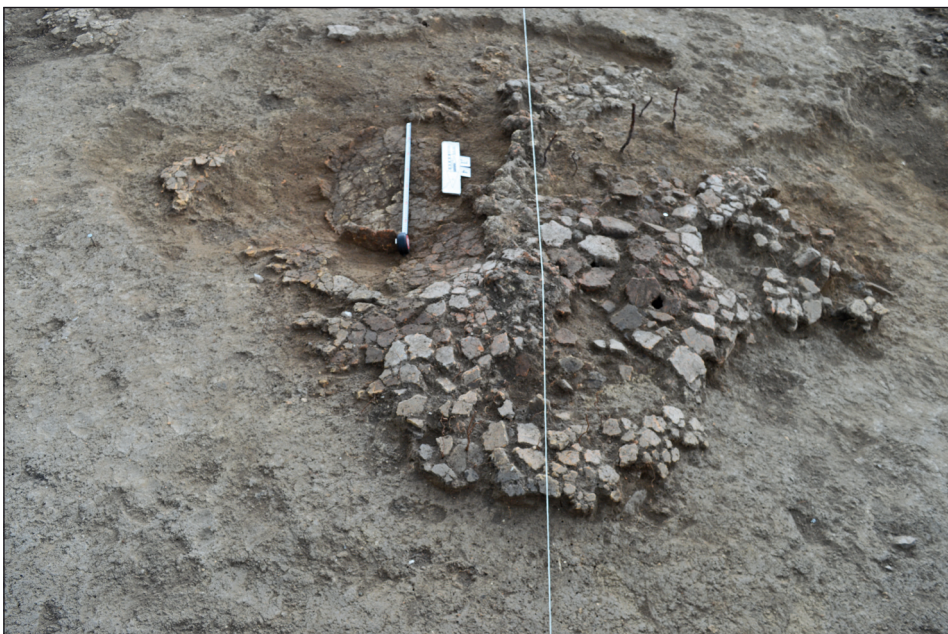
Fig. 10. Voloshkovo 6 (Gorby). Ploshchadka 2, the beam in installation 3. Photo by D. Chernovol

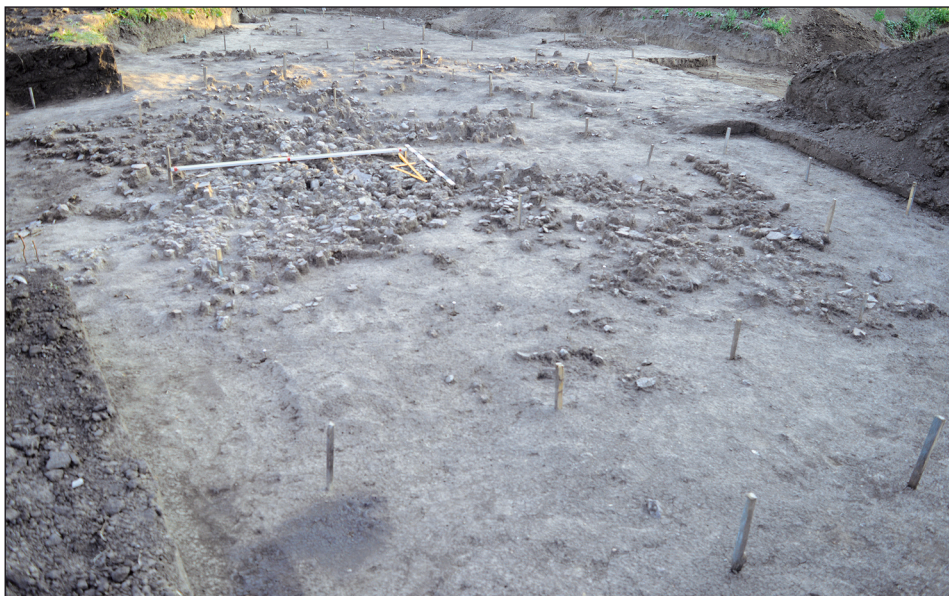
Fig. 11. Voloshkovo 6 (Gorby). Ploshchadka 3. Photo by D. Chernovol

Ploschadka 3 was better preserved. Its walls had collapsed inside the building and visually resembled a 'platform' (Fig. 11). However, the clay elements of the building, due to the imprints of wood, are associated with walls. This questions the construction techniques of small-sized utility structures.

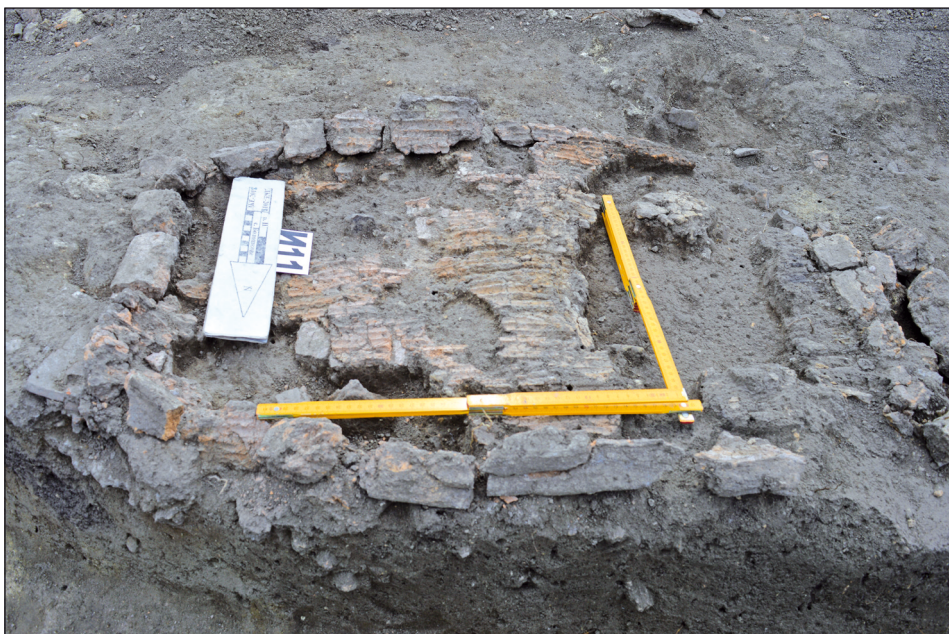
Fig. 12. Voloshkovo 6 (Gorby). Ploshchadka 3, movable table. Photo by D. Chernovol

A number of installations with grinding stones were found on the ground floor of the Ploschadka 3. A movable rectangular table of a size of 0.7×1 m and 0.05 m height was found in the centre of this building (Fig. 12). It is notable that this table had a shape similar to a trough, because its central part had fallen down, while walls below it used as a support remind us of the walls of a trough. One of the long walls of this table had a 0.2 m length depression. The strength of this feature was increased by embedding wooden sticks in the construction. The function of the table is unclear. It rather reminds us of a ritual feature. A mix of calcite was found nearby, indicating the function of the utility structure. Therefore, similar to Ploschadka 2, Ploschadka 3 is associated with activities related to calcite processing.

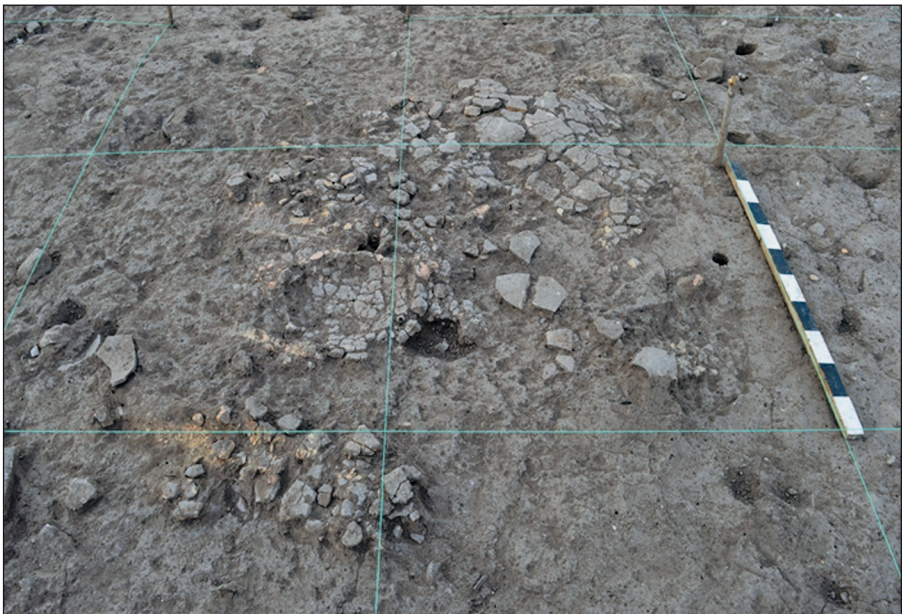
Fig. 13. Bernashevka I. Installation outside dwellings. Photo by D. Chernovol

An installation including a 0.2 m deep round depression of a diameter of 0.3 m covered with clay was found at the Early Tripolye settlement of Bernashevka (Chernovol 2016). Most probably, this depression was used for placing a pot there (Fig. 13). Numerous kitchen pottery sherds were found near this installation. This may indirectly indicate its use for cooking, maybe in summer time. A cluster of fire-affected stones was found between this feature and the nearest house. It is not excluded that these stones were heated on the installation and then used for heating water or for cooking. Five flat stones of a size of 0.2 × 0.3 m were located near the installation at a distance of 3 m from each other forming a “rectangular” perimeter to this feature. The stones could have supported pillars holding up a roof. It should be noted that the “rectangle” was aligned parallel to the ploschadka. The roof might have been used during the rains. If this is the correct interpretation, this feature represents one more variation of the utility structures.
